Memorandum

To	Hansen Yuncken Pty Ltd	Marcus Amico	mamico@hansenyuncken.com.au
From	Jeremy Hill	Date	05 Oct 2023
Subject	UNSW Health Translation Hub Corner of Botany and High Streets, Randwick	Project No.	99852.02
		Document No.	VR.004.Rev0

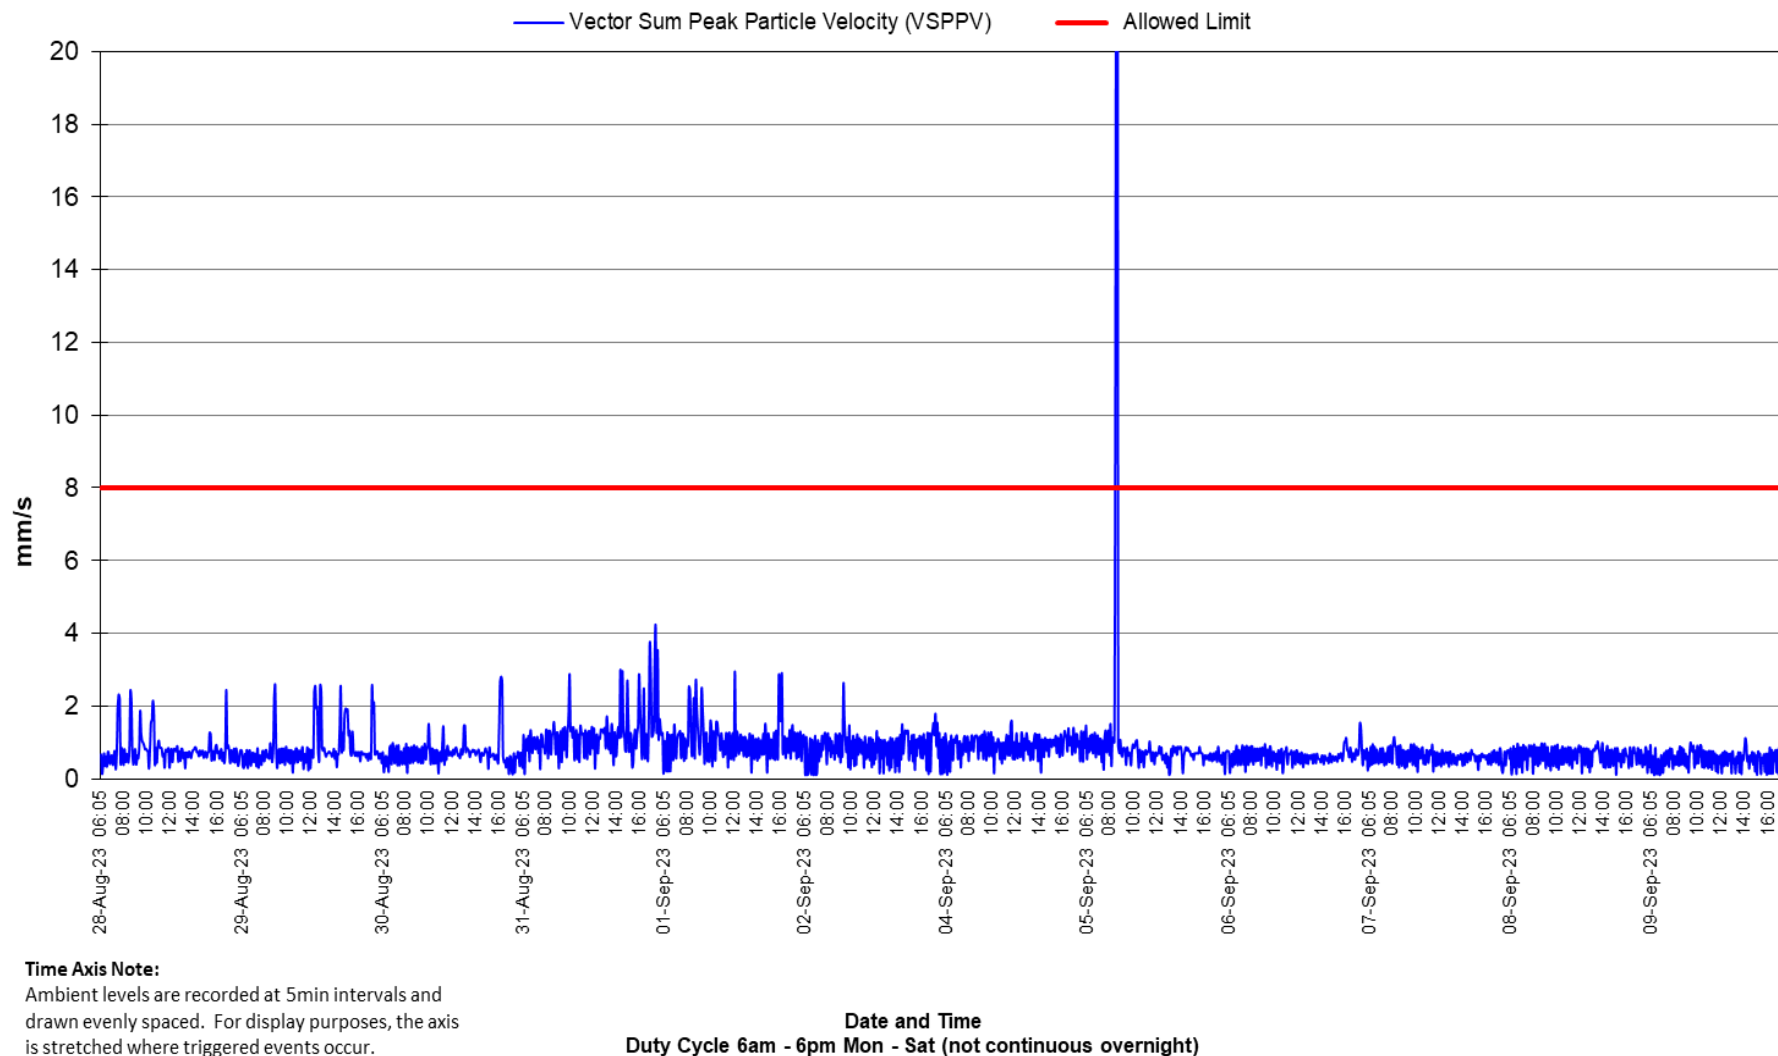
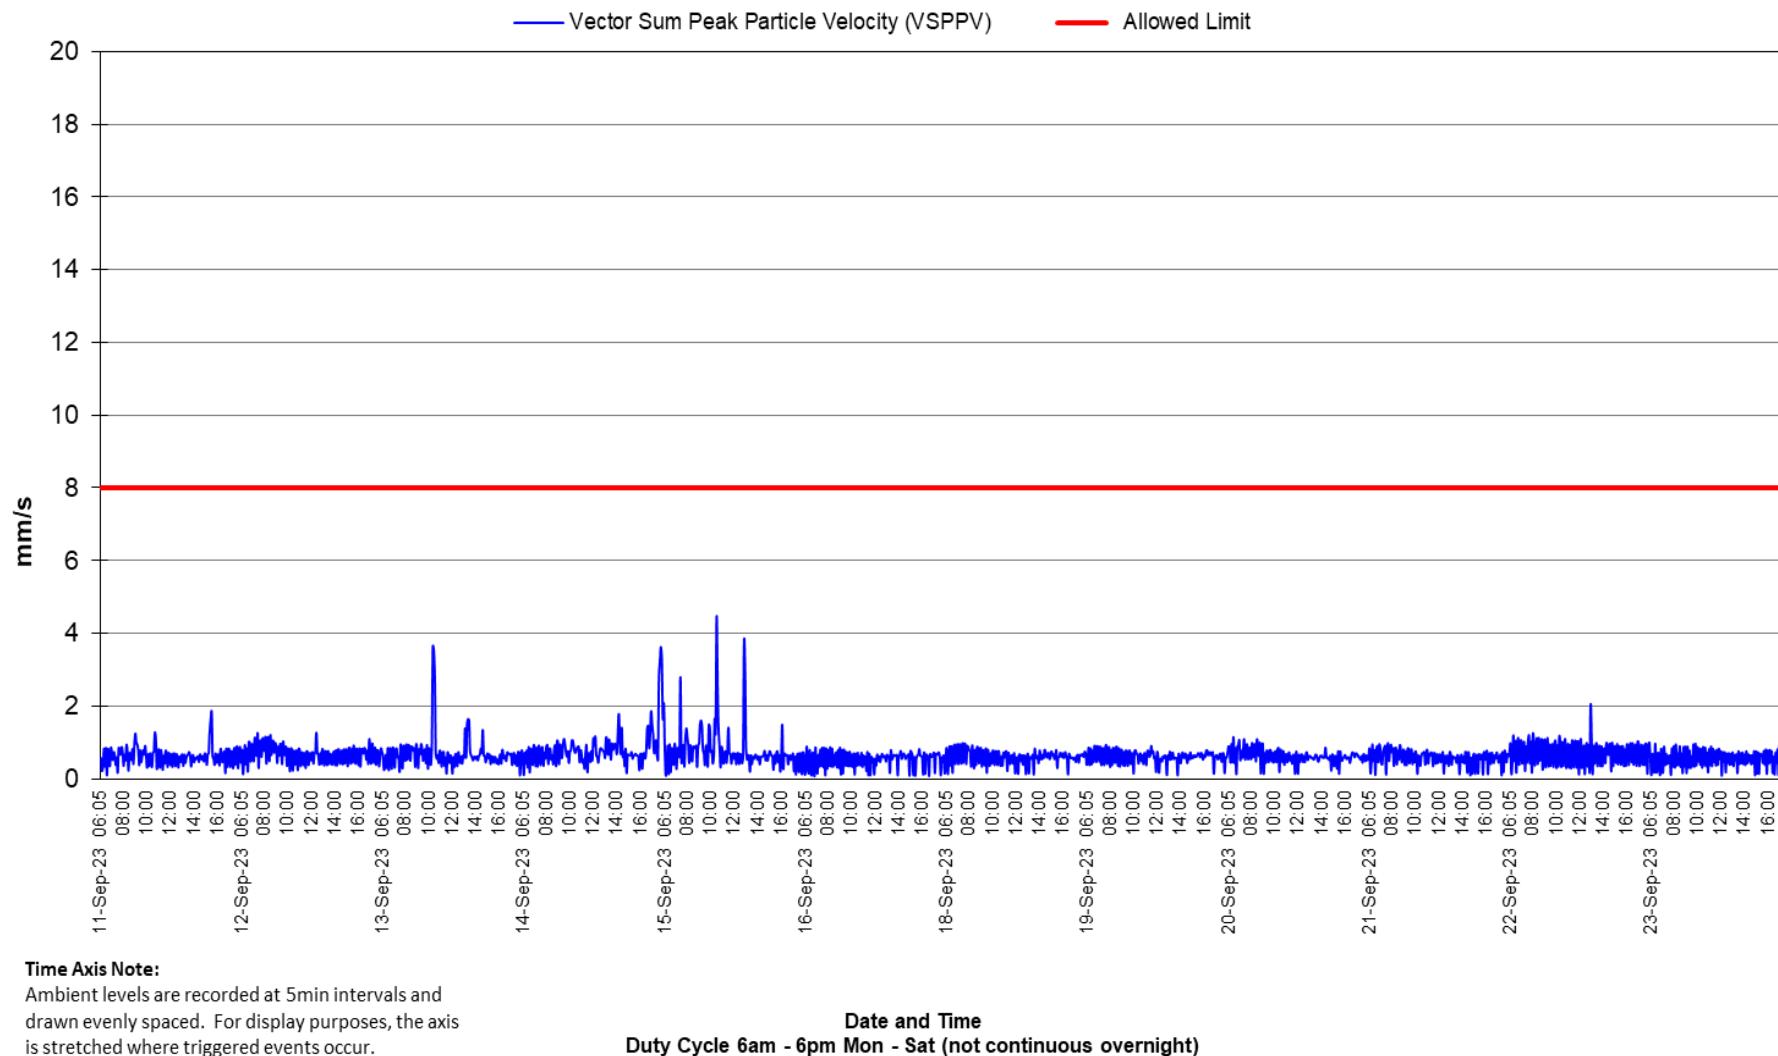
Vibration Levels - Corner of Botany and High Streets, Randwick Monitoring Location B

Location	Monitor	Exceedances (VSPPV)		Time of maximum exceedance
		No.	Max (mm/s)	
Monitoring Location A	7222	0	-	-
Monitoring Location B	7285	2*	29.3	5-Sep, 8:33 am

Notes: *Analysis of waveform indicates exceedances were likely caused by a direct impact to sensor or near to the sensor.
