Memorandum

To	Hansen Yuncken Pty Ltd	Marcus Amico	mamico@hansenyuncken.com.au
From	Jeremy Hill	Date	23 Oct 2023
Subject	UNSW Health Translation Hub Corner of Botany and High Streets, Randwick	Project No.	99852.02
		Document No.	VR.005.Rev0

Table 1: Results of Vibration Monitoring, 25 September – 21 October 2023

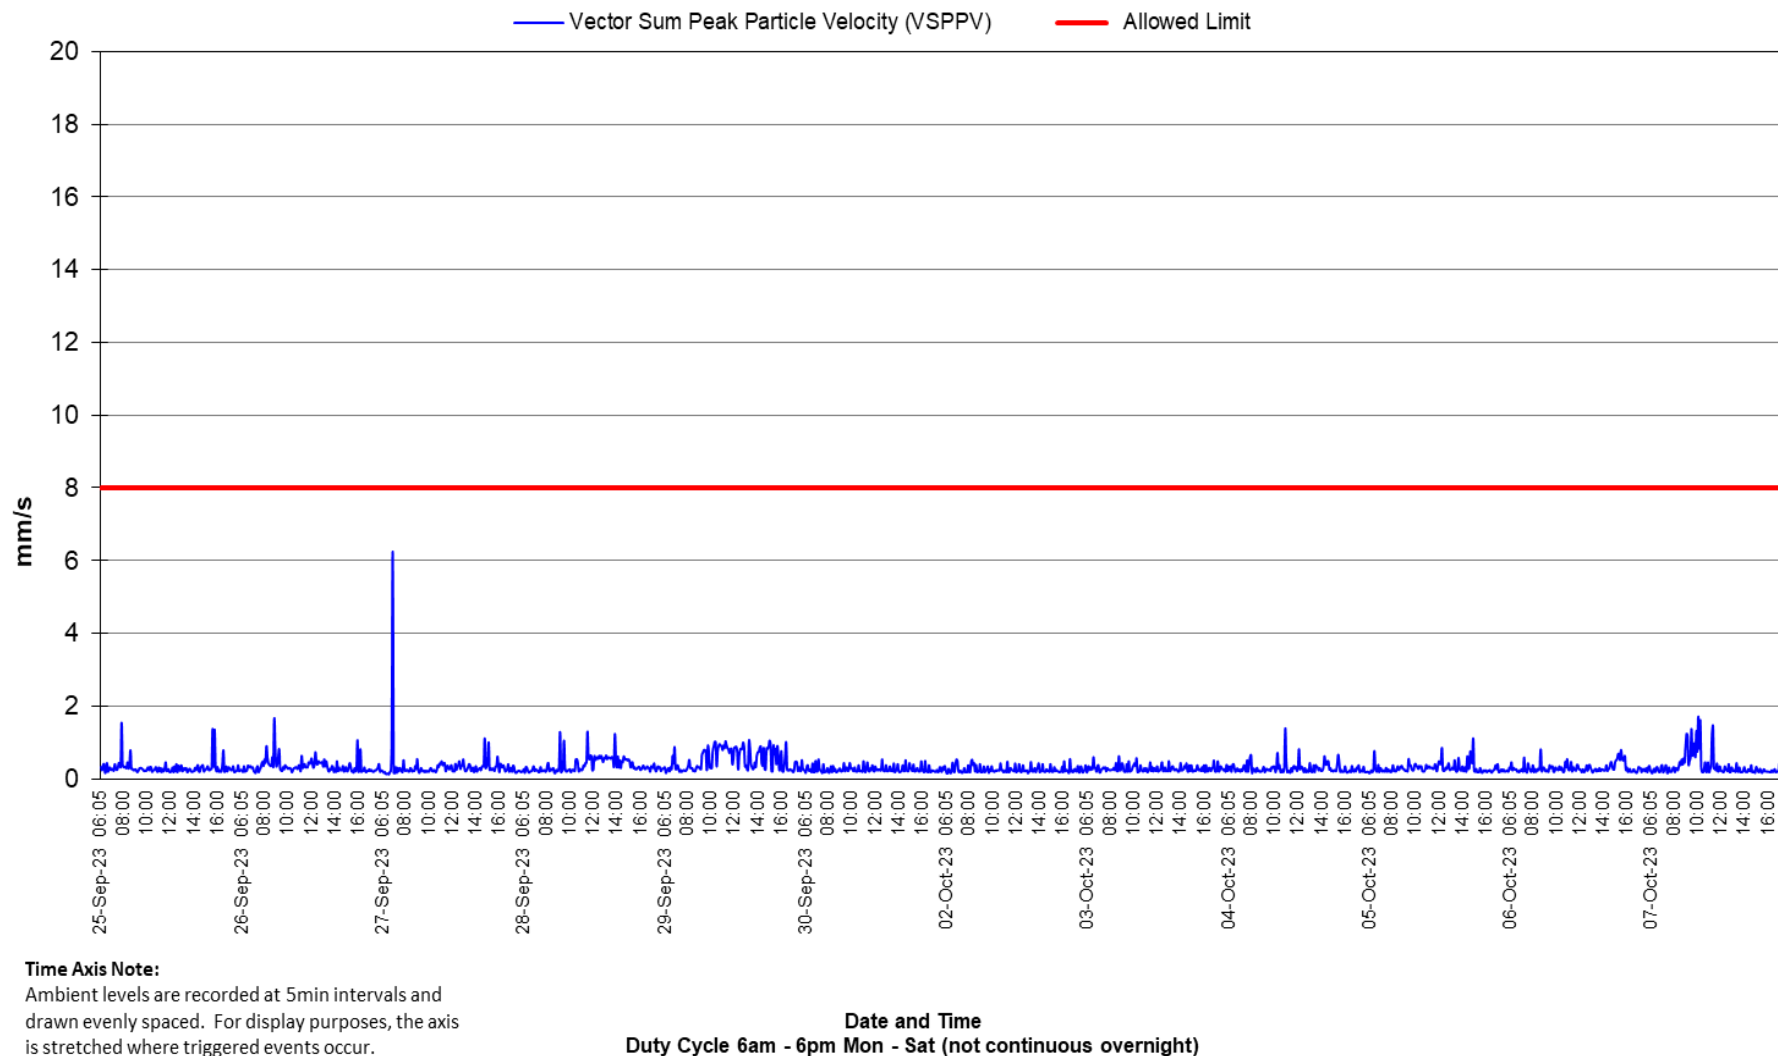
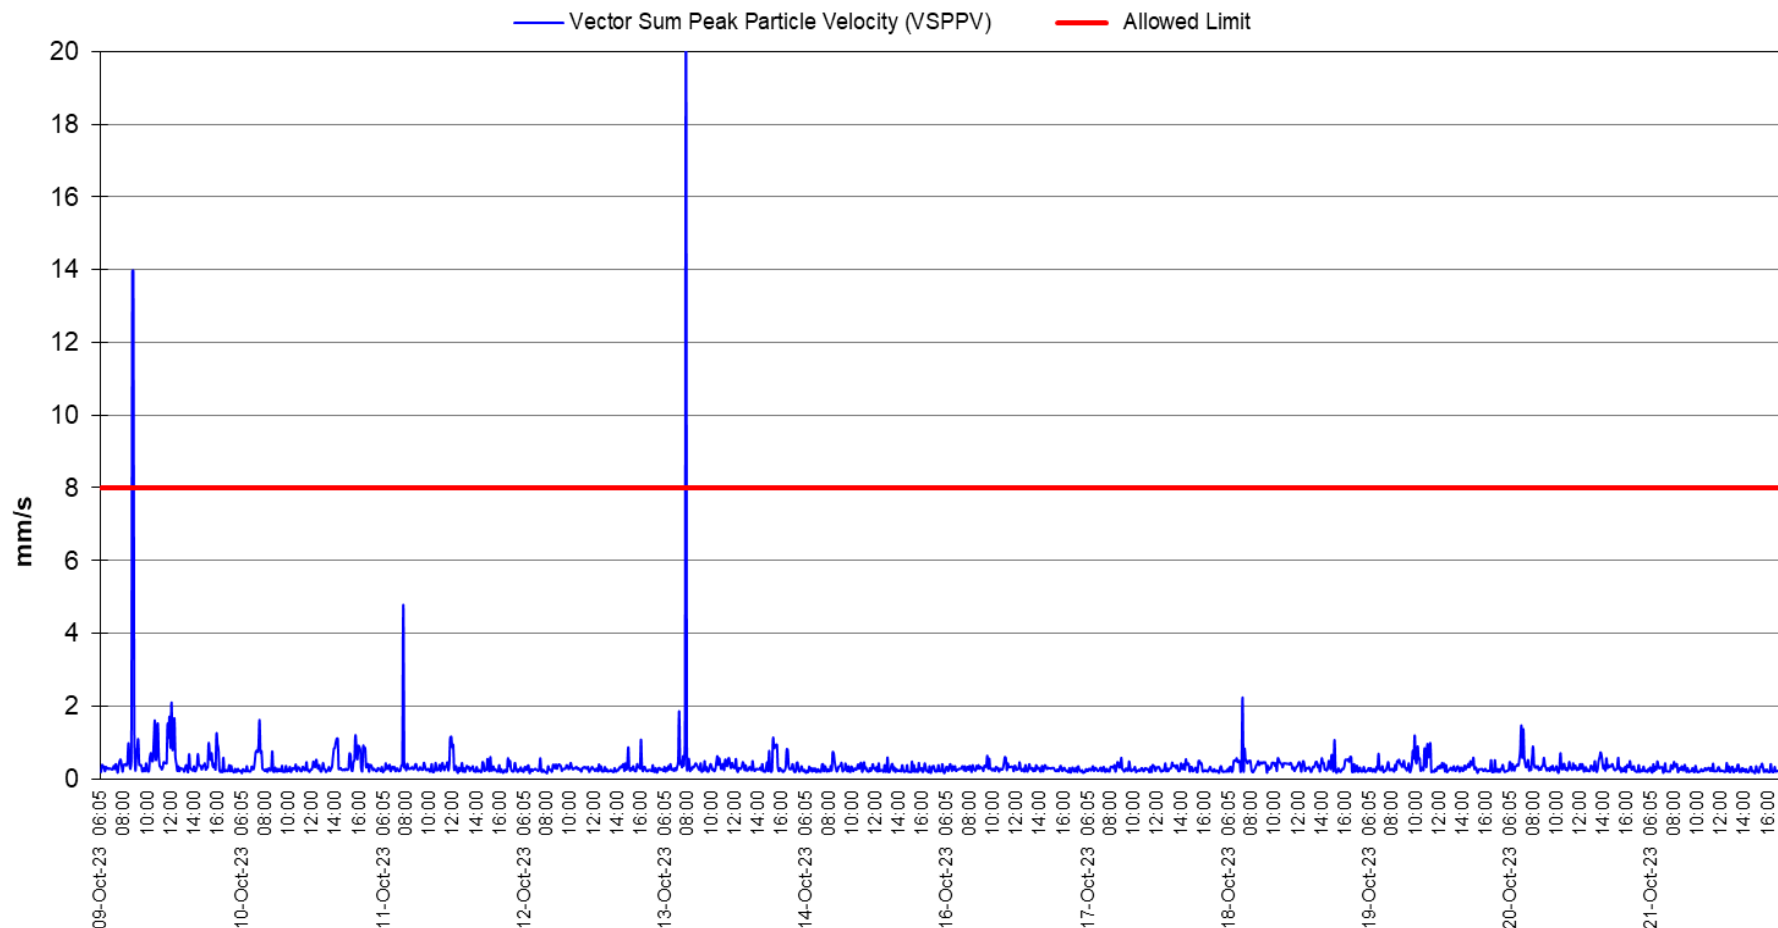
Monitor **7222**

Location	Monitor	Exceedances (VSPPV)		Time of maximum exceedance
		No.	Max (mm/s)	
Monitoring Location A	7222	2*	22.3	13-Oct, 7:50 am
Monitoring Location B	7285	0	-	-

Notes: *Analysis of waveforms indicates that the exceedance on 9-Oct was an isolated impulsive event, possible direct bump to sensor. The exceedance on 13-Oct was a transient event, likely caused by electrical interference (no waveform recorded or SMS alarm was triggered for this event).

Vibration Levels - Corner of Botany and High Streets, Randwick Monitoring Location A

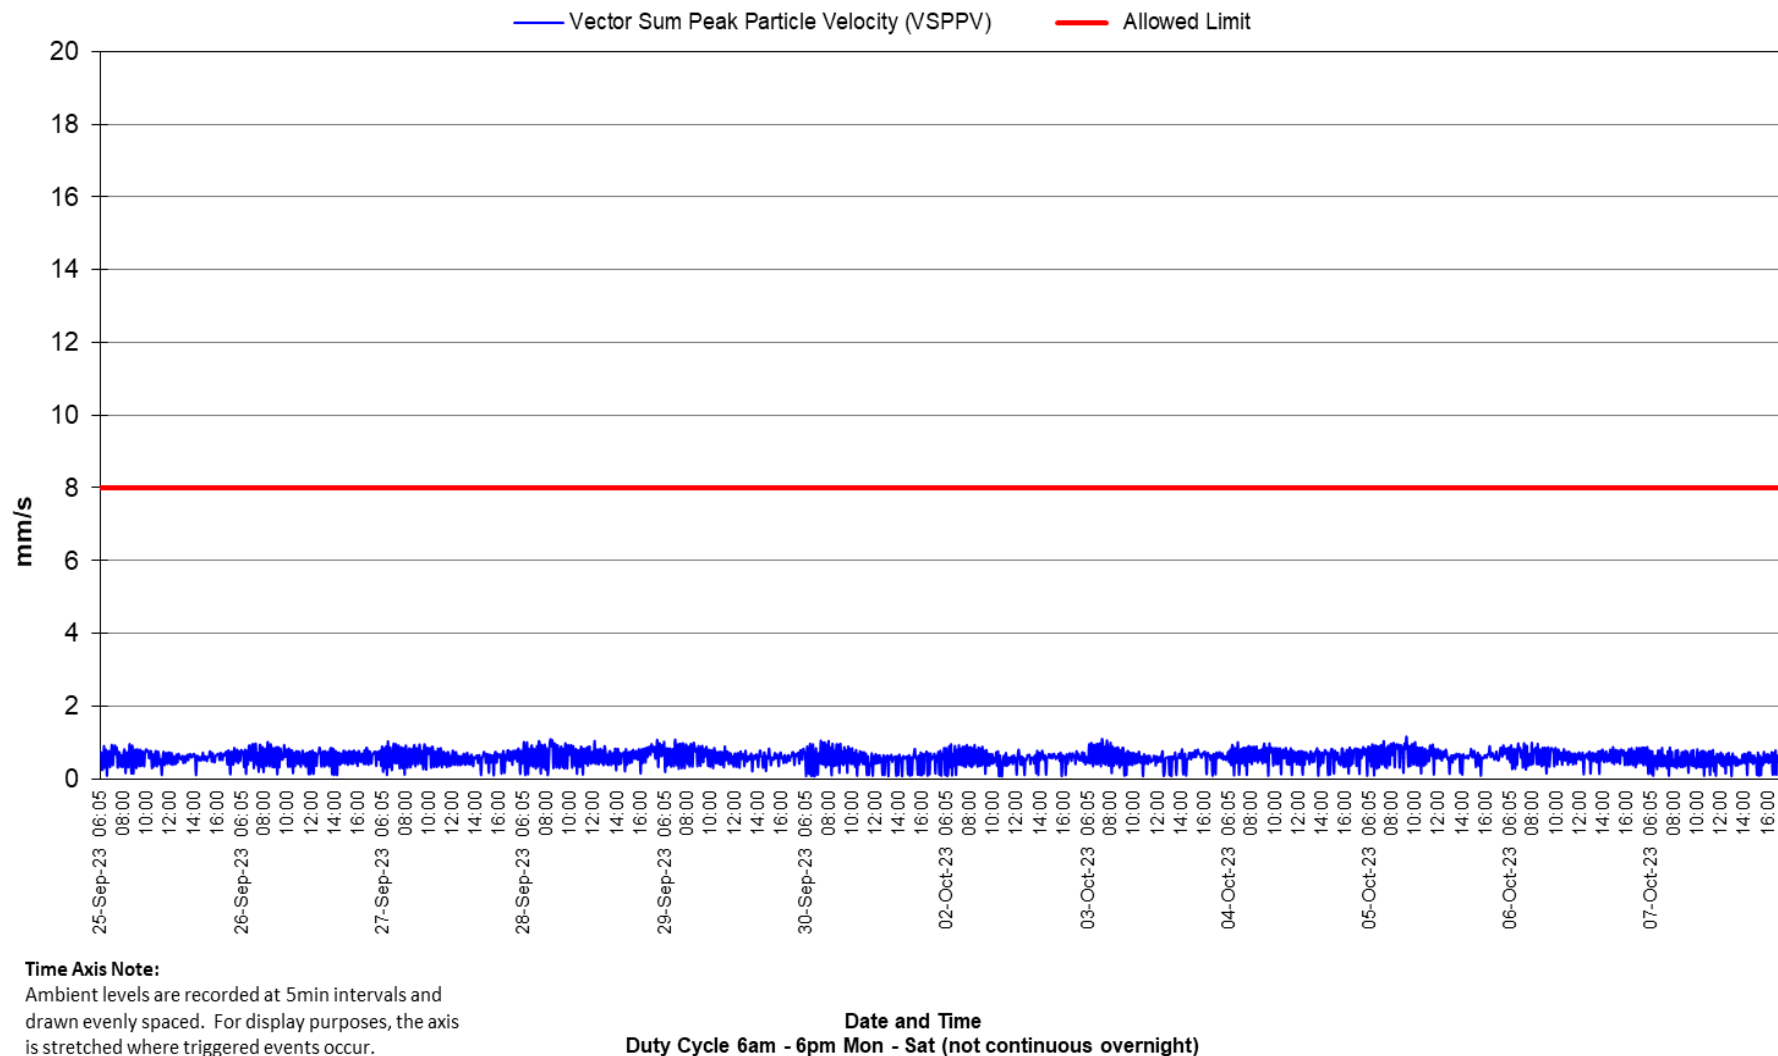
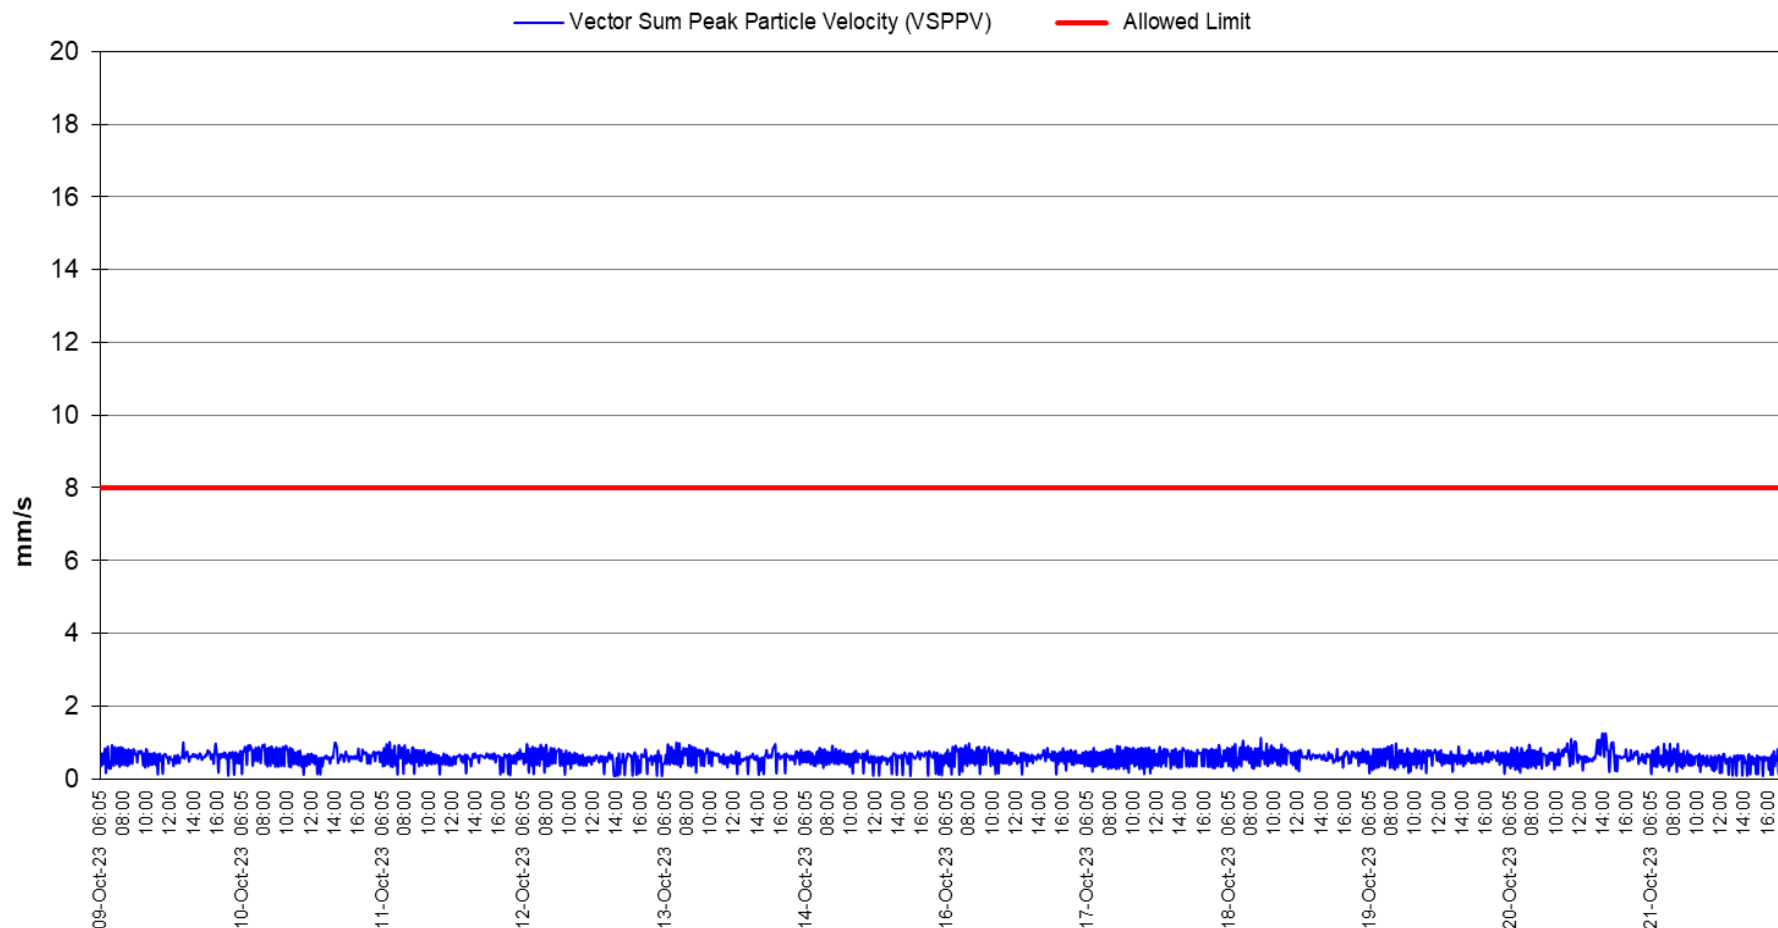
Monitor **7285**

Vibration Levels - Corner of Botany and High Streets, Randwick Monitoring Location B
