Memorandum

To	Hansen Yuncken Pty Ltd	Marcus Amico	mamico@hansenyuncken.com.au
From	Jeremy Hill	Date	20 Nov 2023
Subject	UNSW Health Translation Hub Corner of Botany and High Streets, Randwick	Project No.	99852.02
		Document No.	VR.006.Rev0

Table 1: Results of Vibration Monitoring, 23 October – 18 November 2023

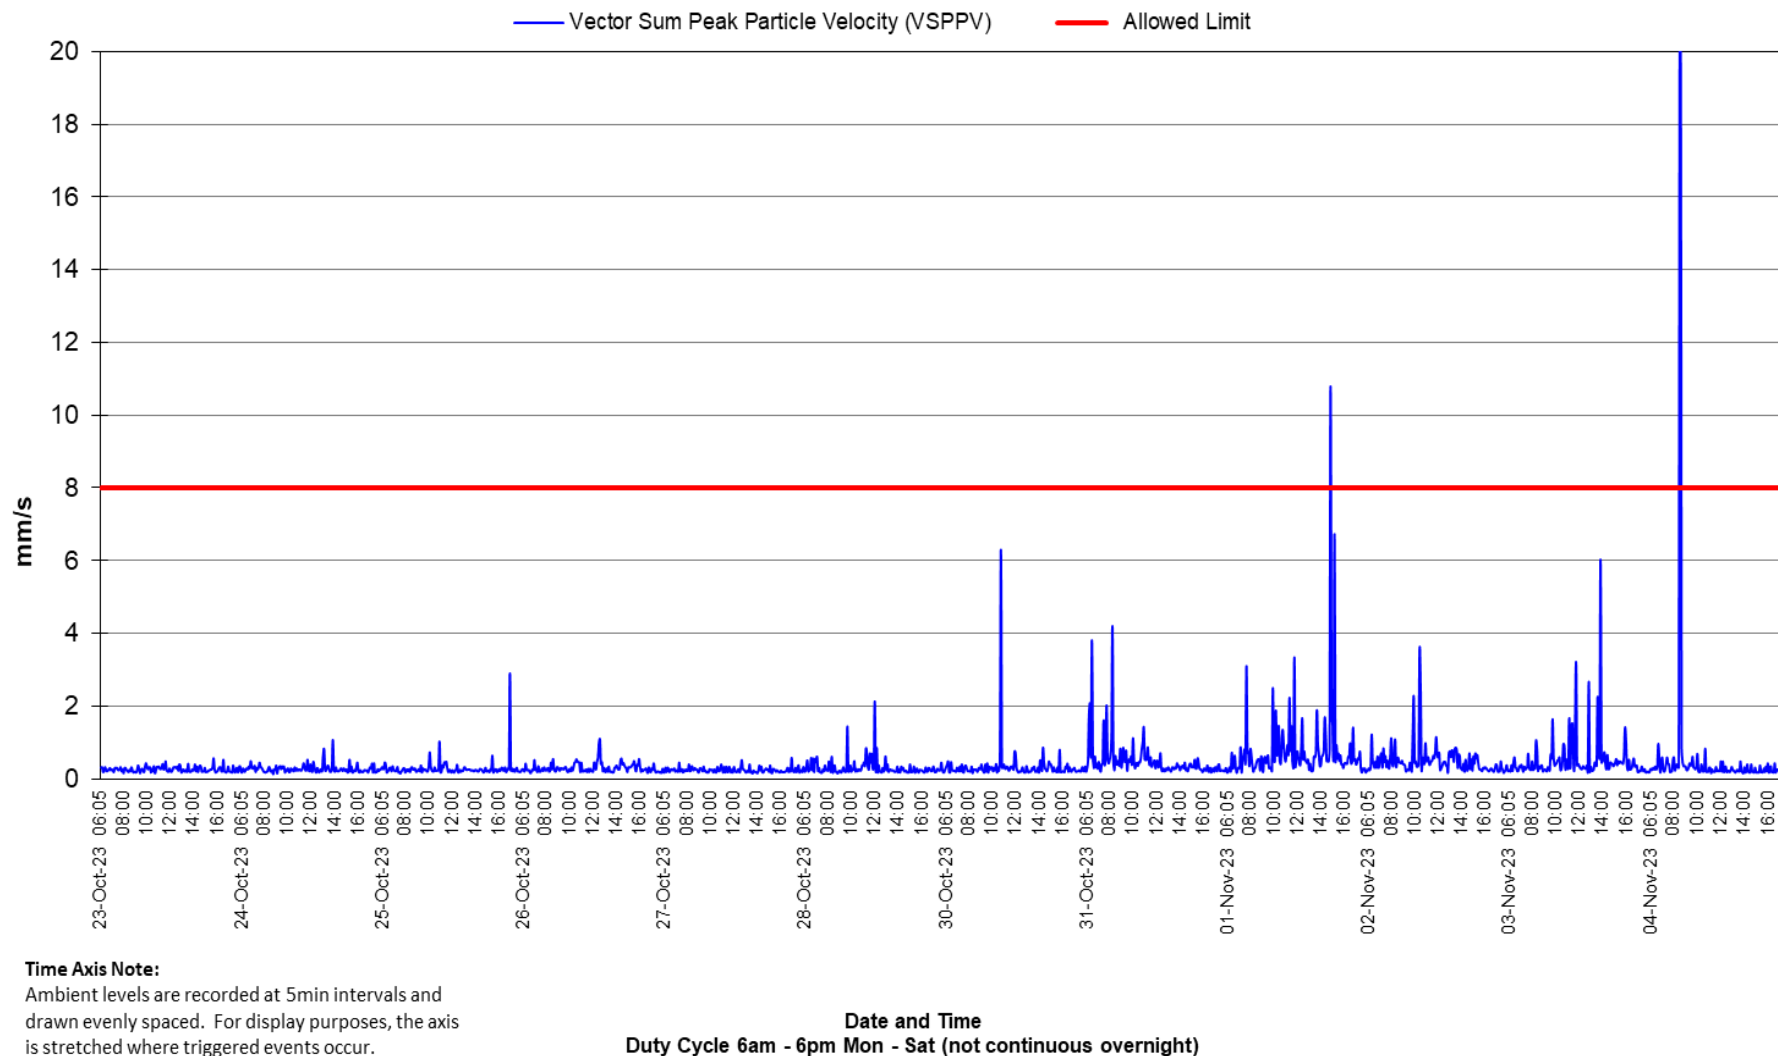
Vibration Levels - Corner of Botany and High Streets, Randwick Monitoring Location A

Notes: *Analysis of waveforms indicates that the exceedance on 4-Nov was an isolated impulsive event, possible direct bump to sensor. The exceedance on 1-Nov was a transient event, likely caused by electrical interference (no waveform recorded or SMS alarm was triggered for this event).
