## Memorandum

<b>To</b>	Hansen Yuncken Pty Ltd	Marcus Amico	mamico@hansenyuncken.com.au
<b>From</b>	Jeremy Hill	<b>Date</b>	29 Aug 2023
<b>Subject</b>	UNSW Health Translation Hub Corner of Botany and High Streets, Randwick	<b>Project No.</b>	99852.02
		<b>Document No.</b>	VR.003.Rev0

**Table 1: Results of Vibration Monitoring, 31 July – 26 August 2023**

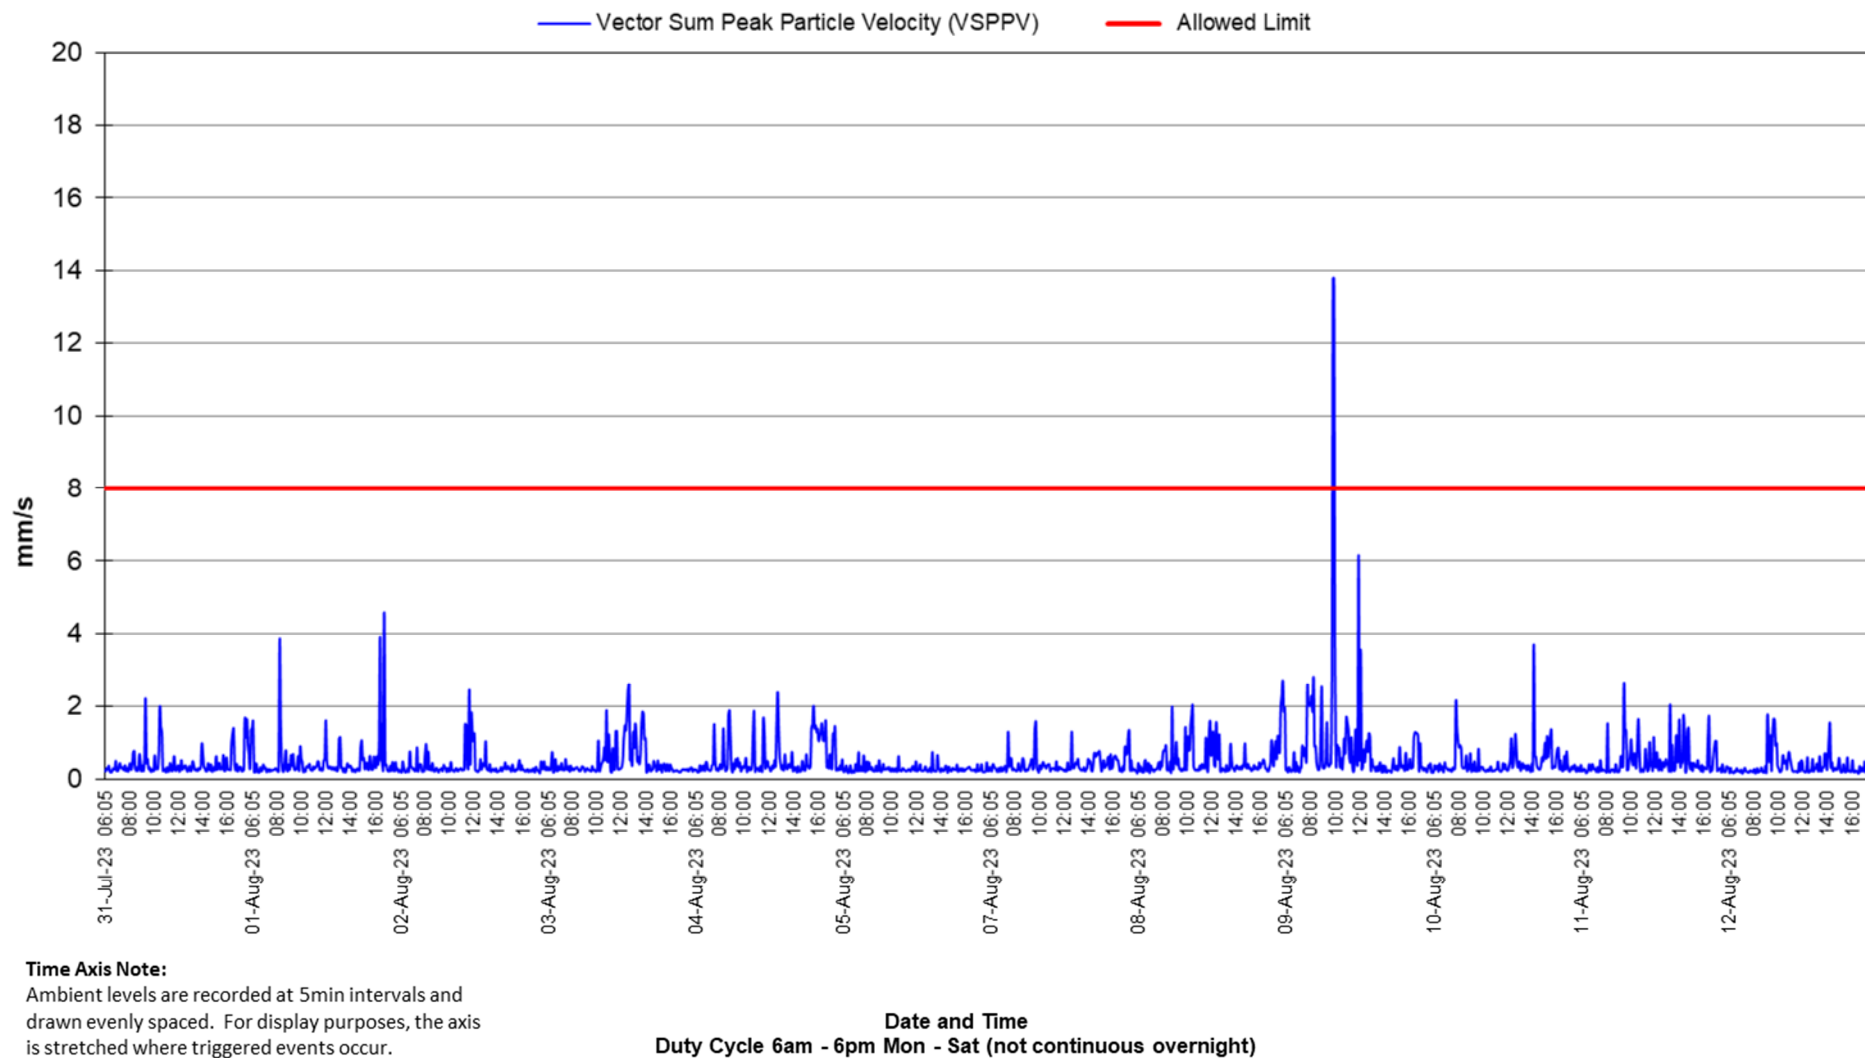
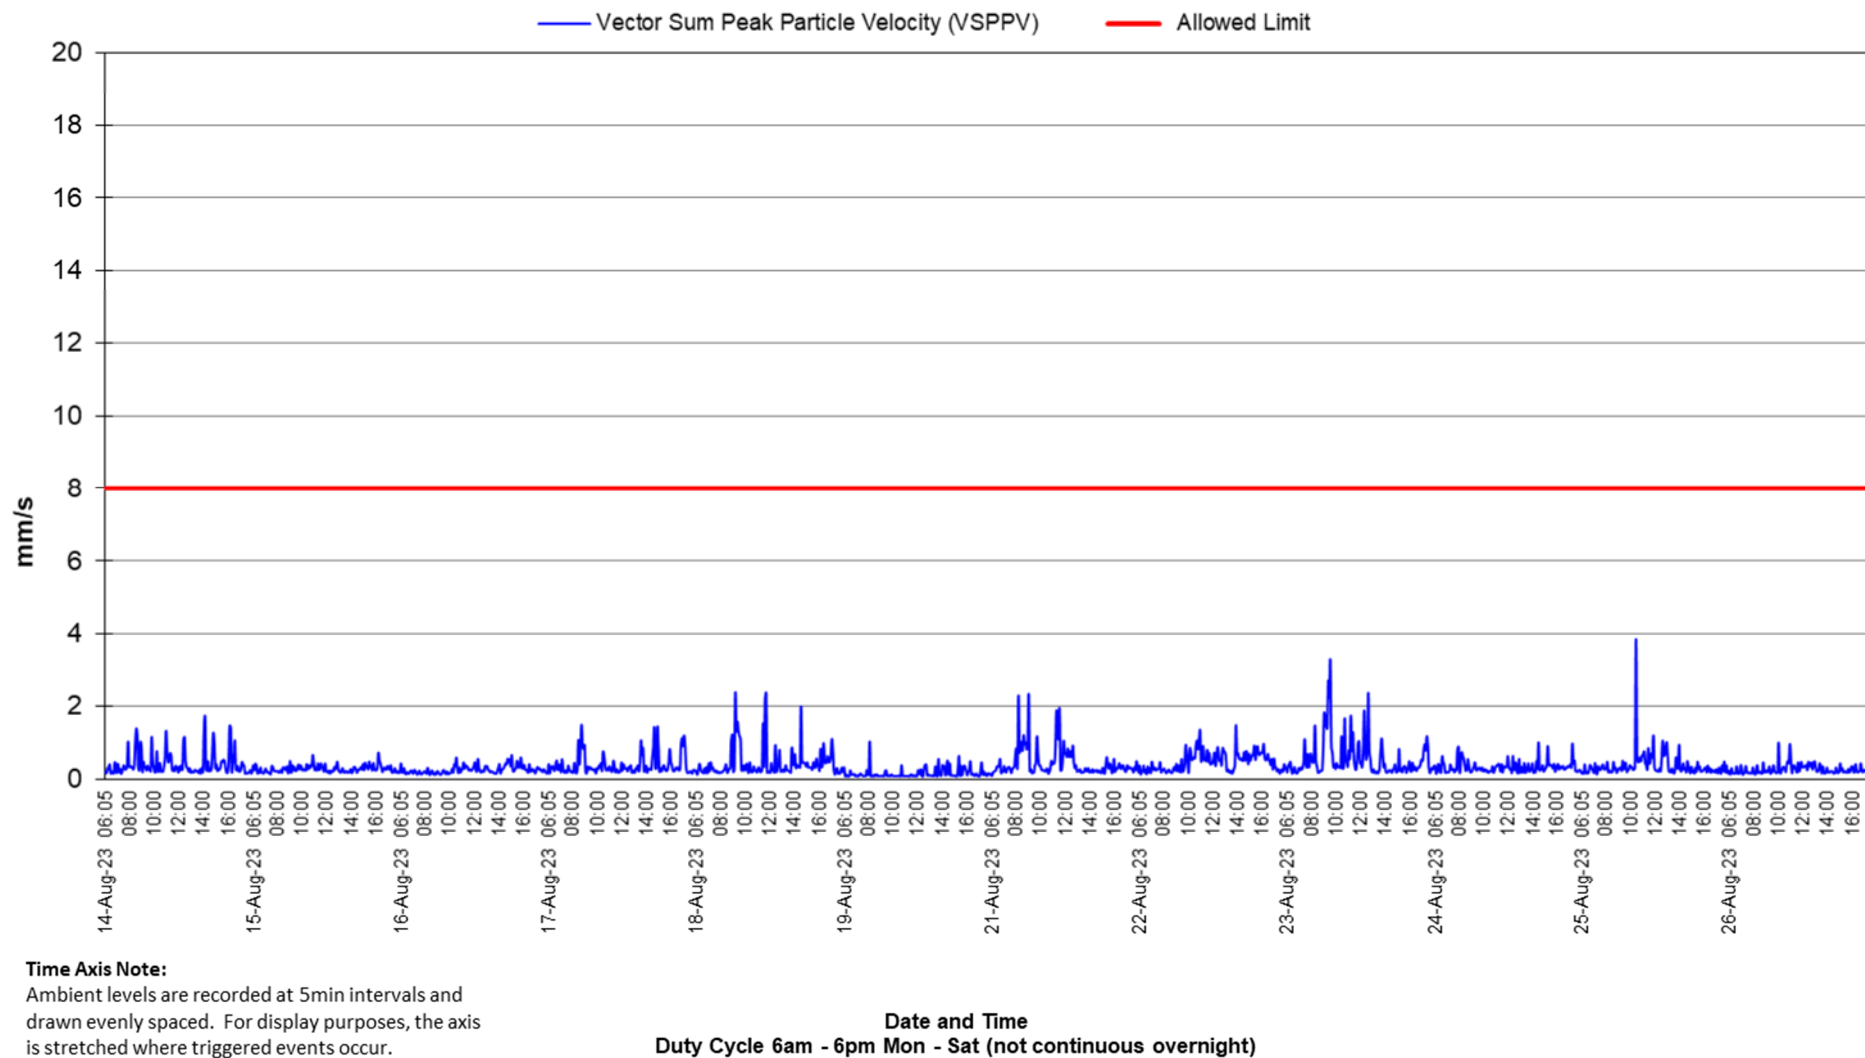
Monitor **7222**

Notes: \*Analysis of waveform indicates exceedance was an isolated impulsive event. Possibly caused by a direct impact to sensor or near to the sensor.

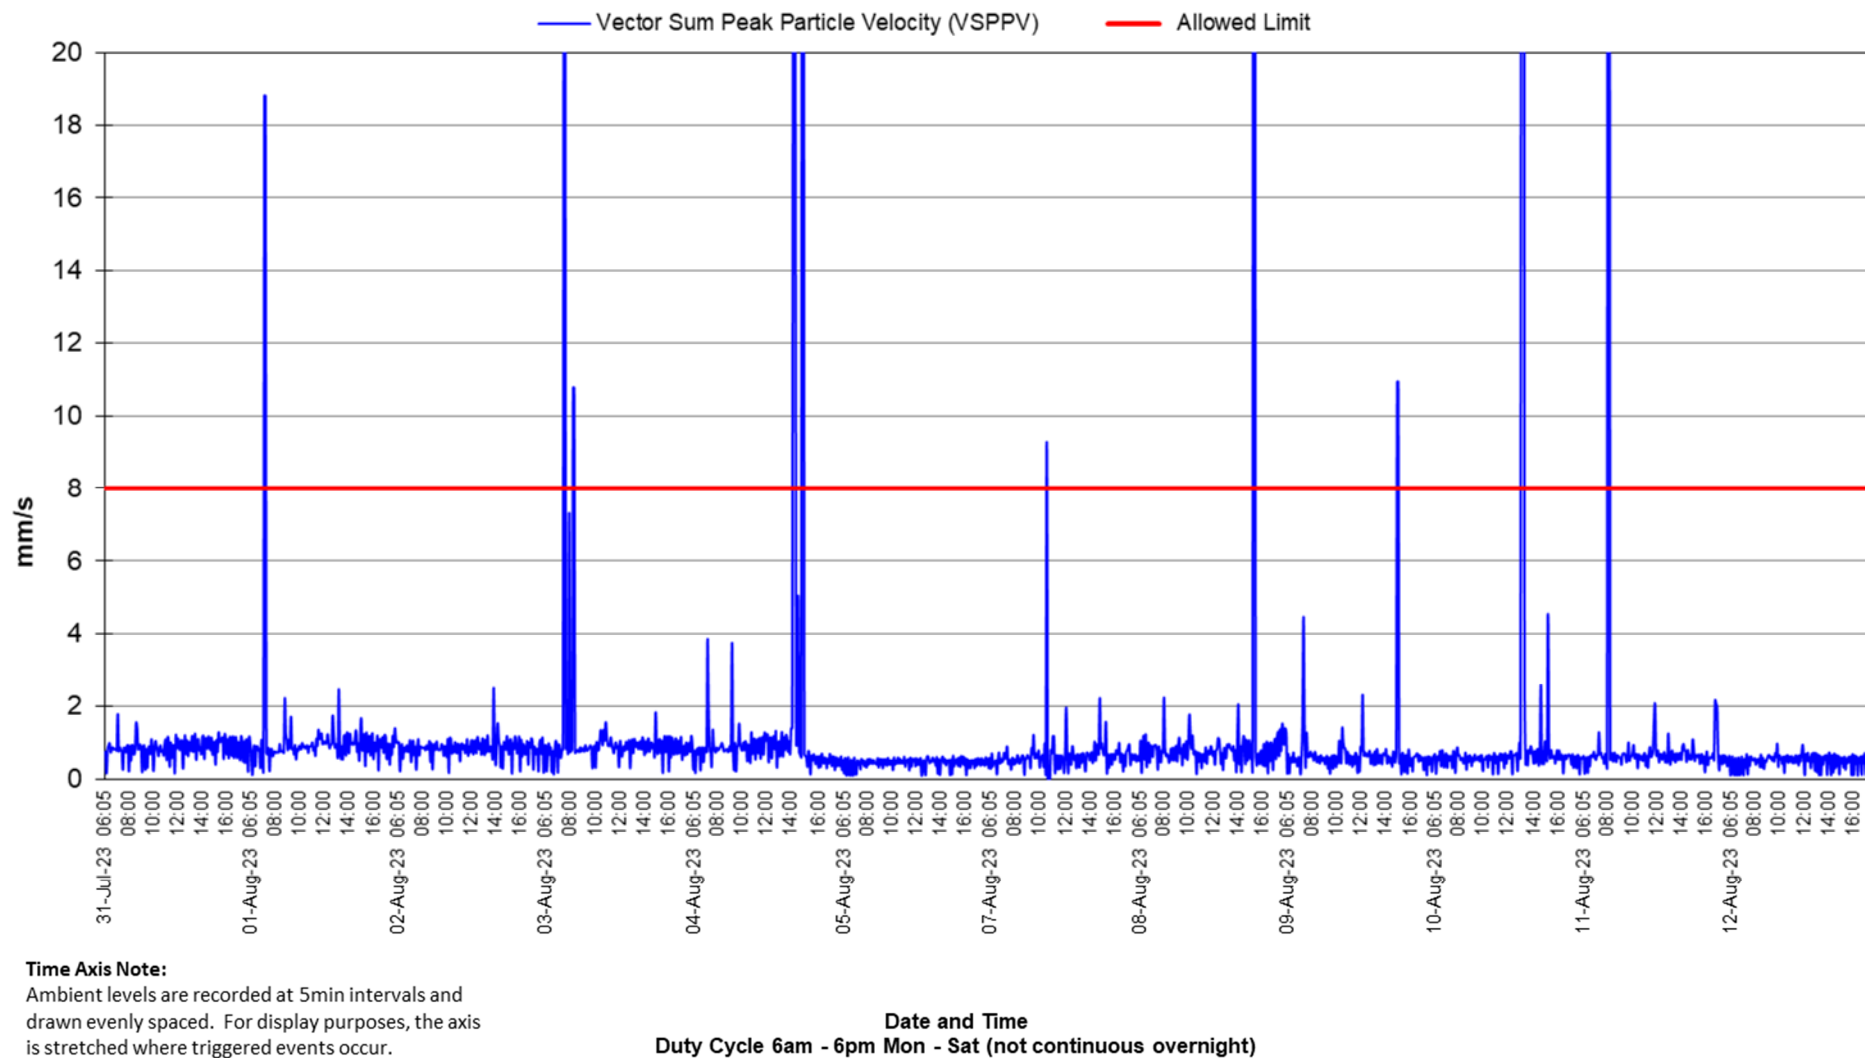
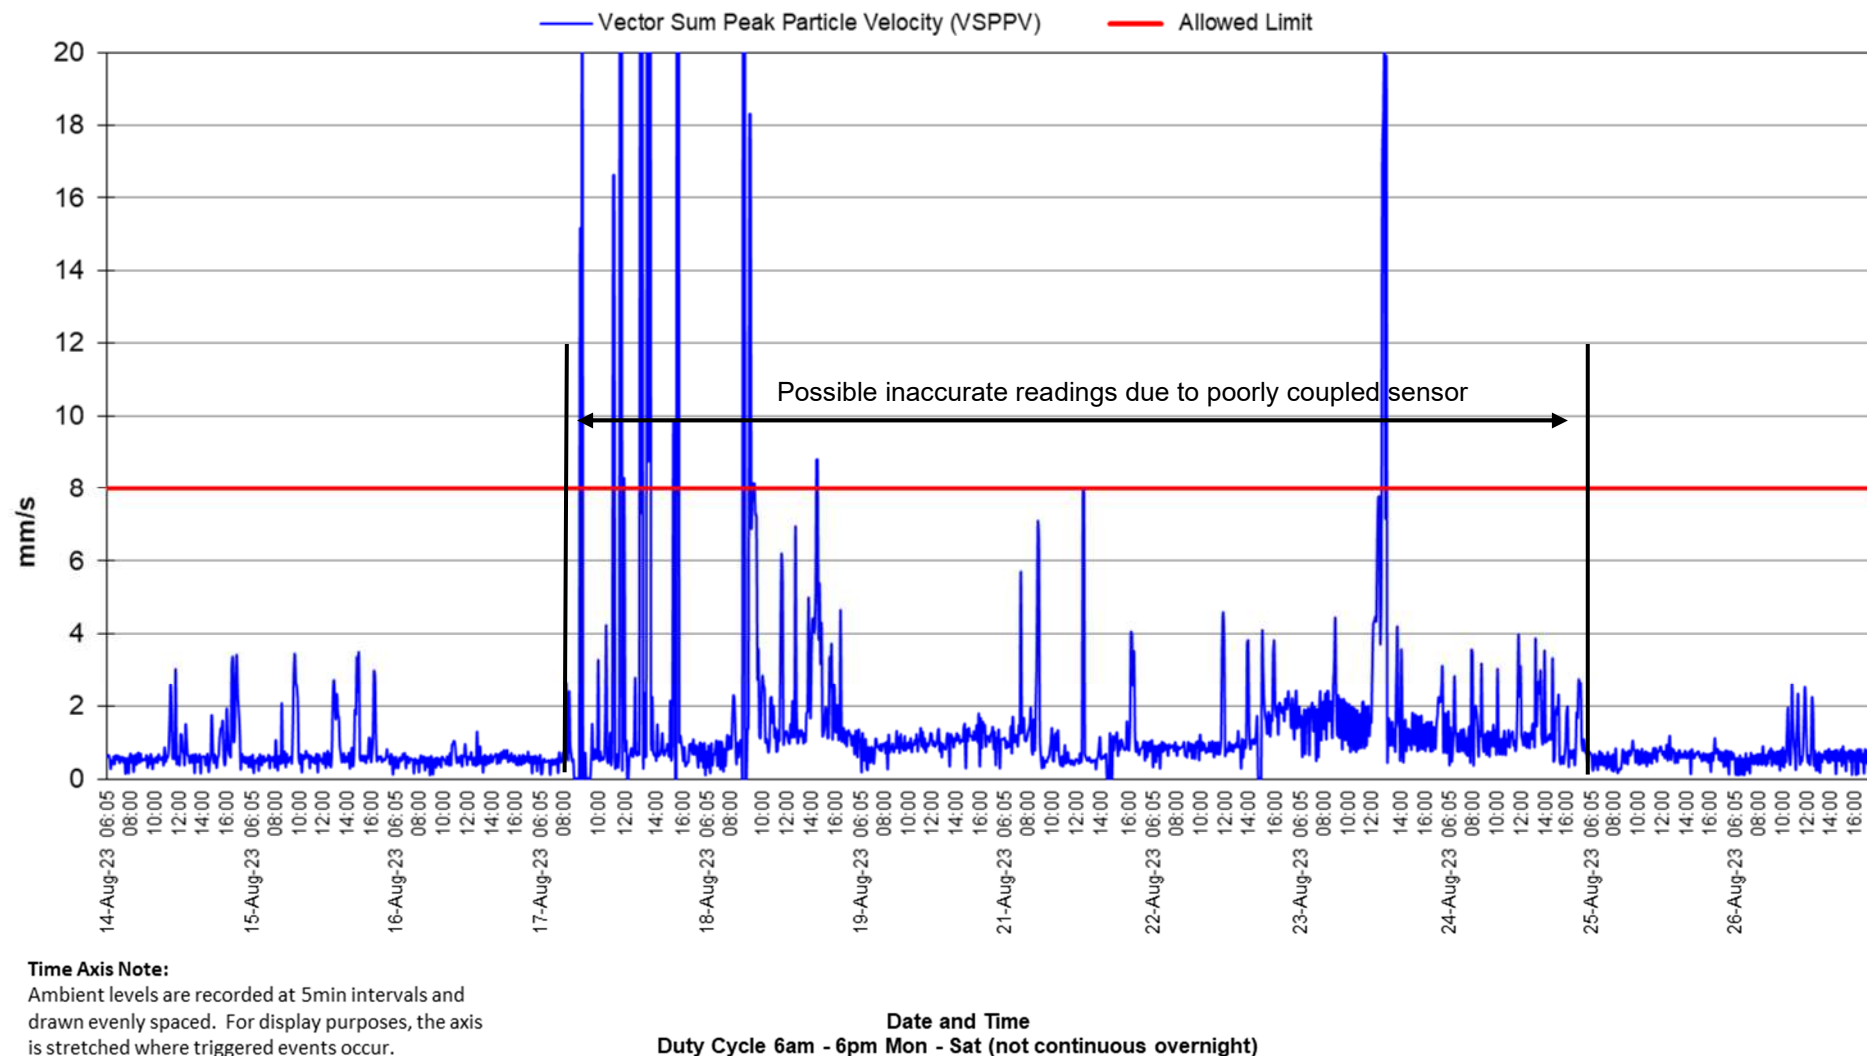
Monitor **7285**

\*\* Analysis of waveforms for the period indicates that most exceedances were impulsive events, likely caused by direct bumps to or movement of sensor. The site manager reported that staff were bumping the sensor during plumbing works on 17 and 18 August. A DP site visit on 24 August found that the sensor was dislodged from its original mounting position on the ground surface. The sensor was subsequently reinstalled correctly. The vibration levels recorded for the period 17-24 August by Monitor 7285 may be inaccurate due to improper coupling of the sensor with the ground.
