Memorandum

To:	Hansen Yuncken Pty Ltd	Date:	14 March 2024
Attention:	Marcus Amico	Project No.:	99852.02
Email:	mamico@hansenyuncken.com.au	Reference:	VR.010.Rev0
From:	Jeremy Hill		
Subject:	UNSW Health Translation Hub Corner of Botany and High Streets, Randwick

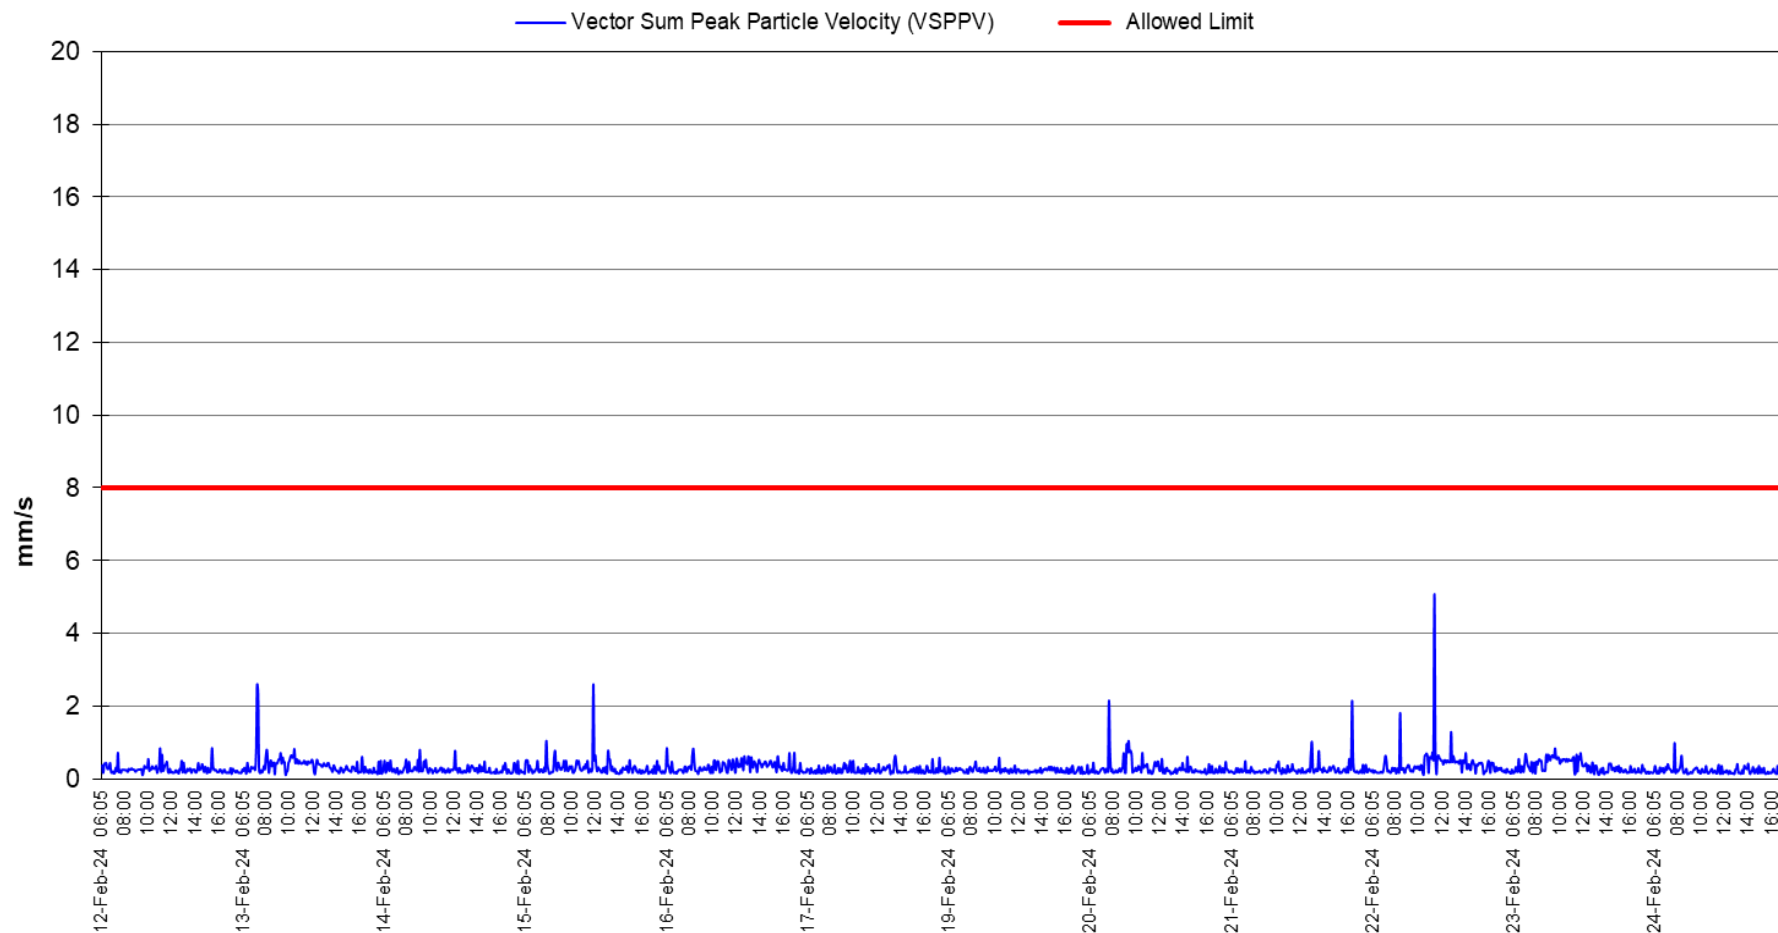
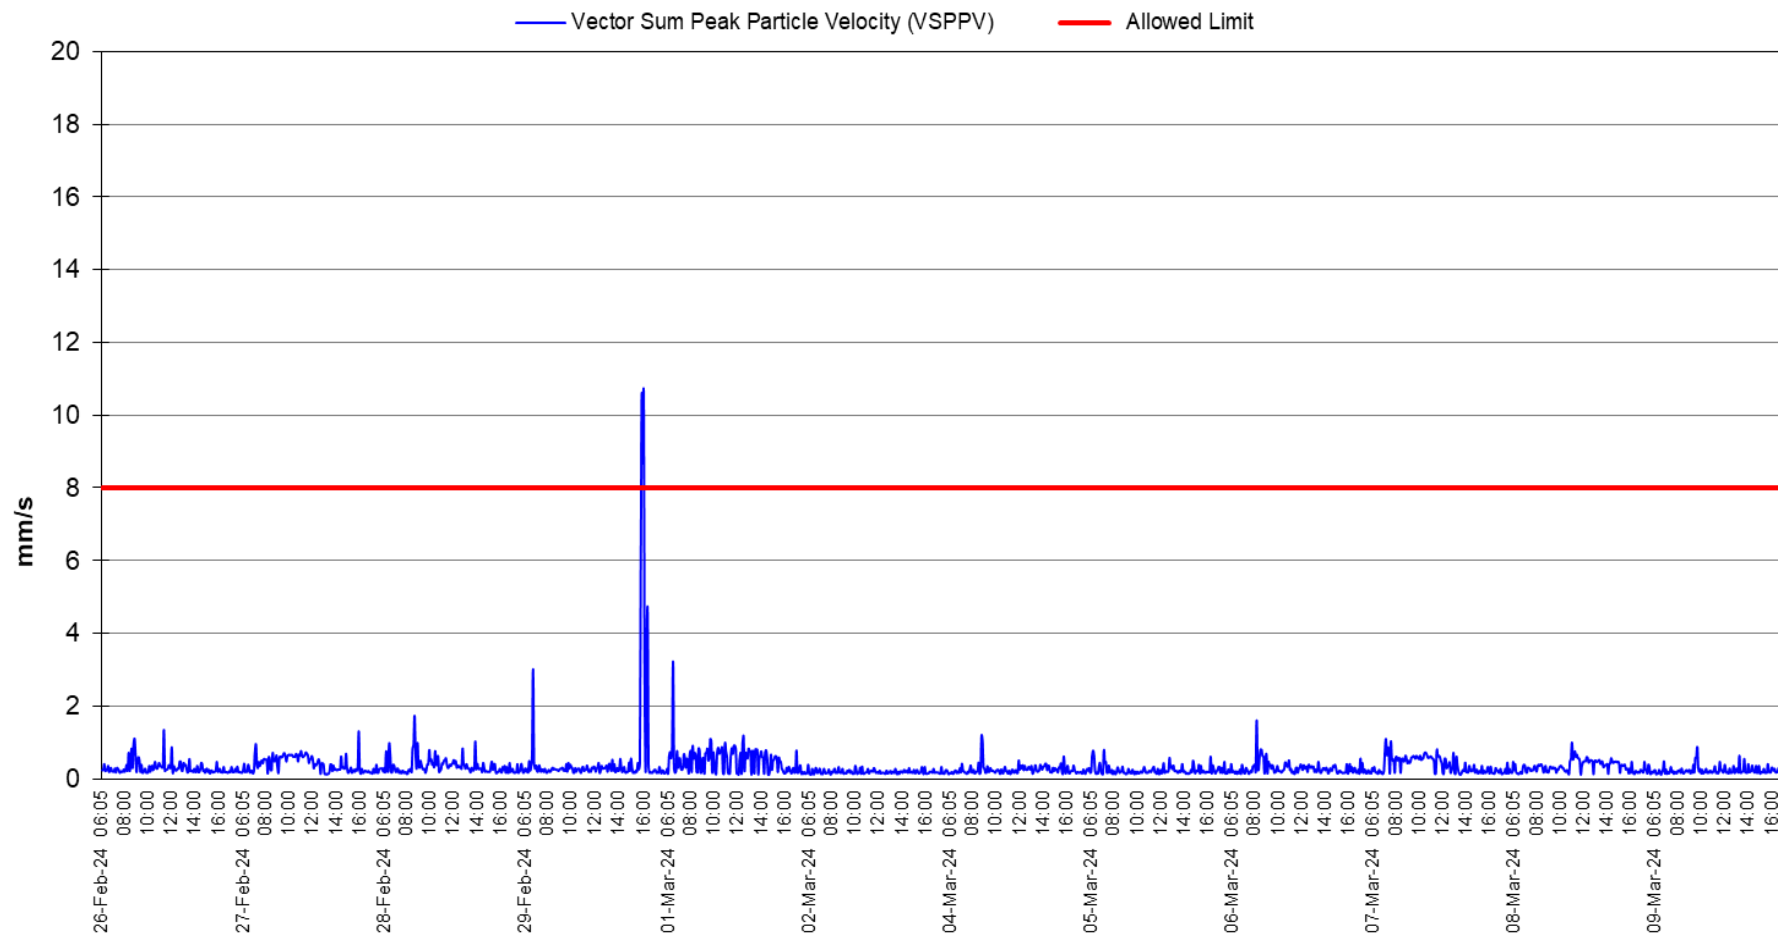
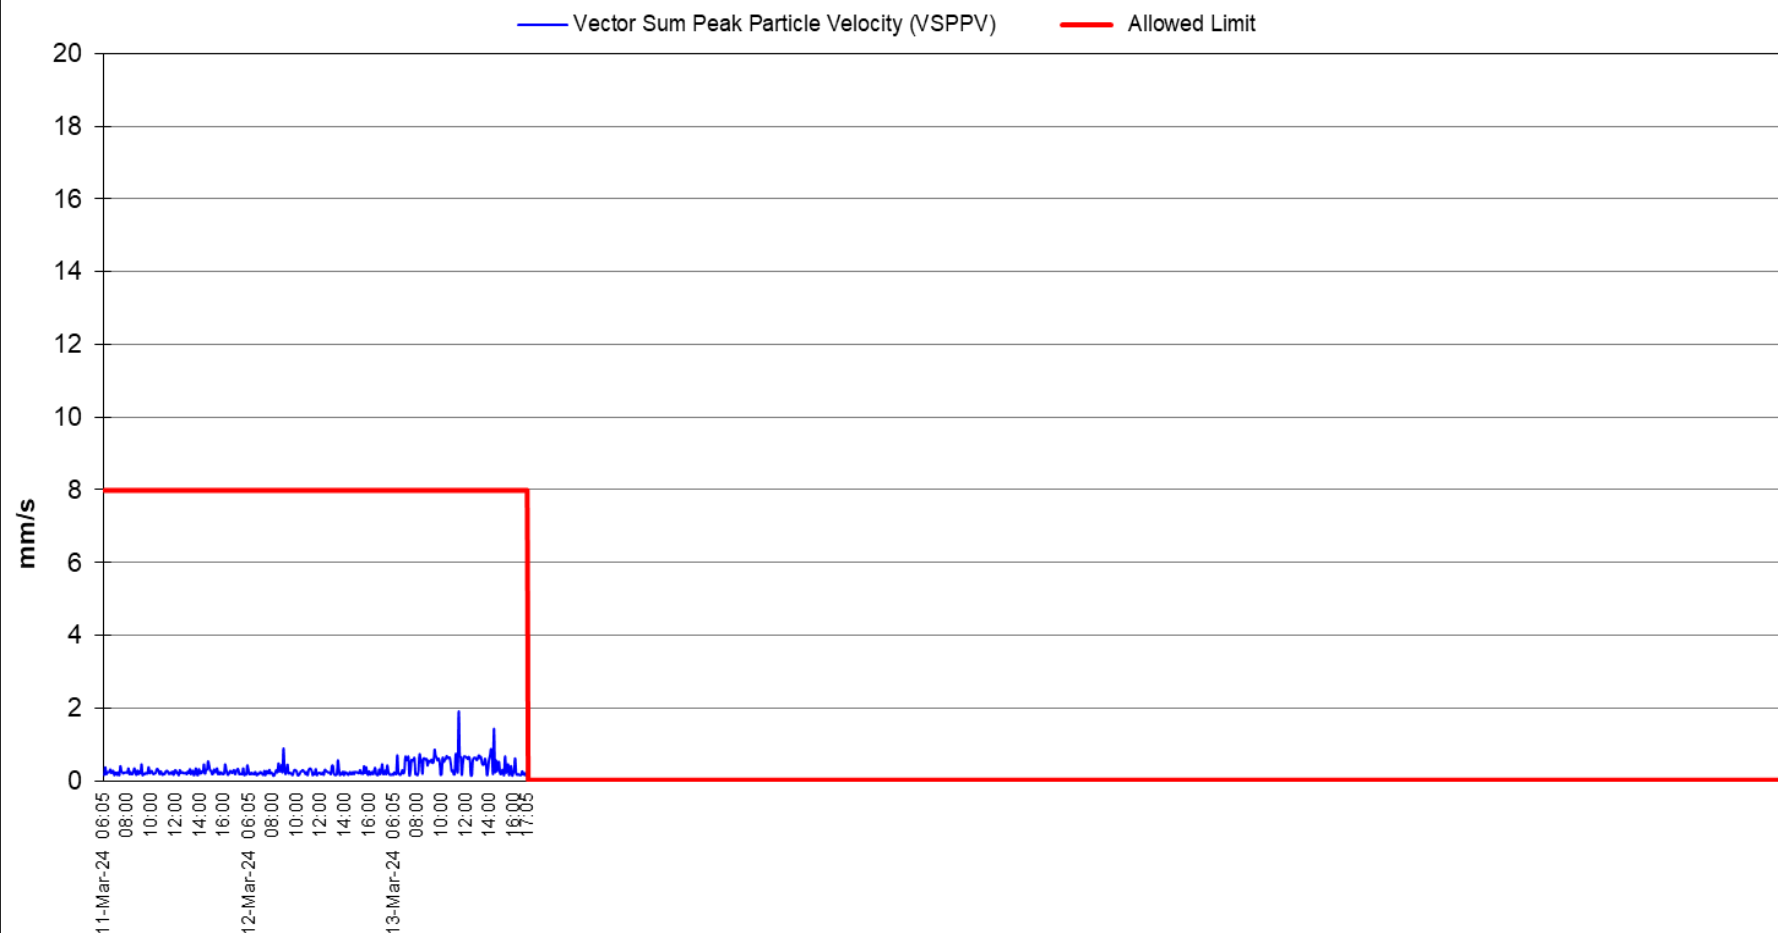
Location	Monitor	Exceedances (VSPPV)		Time of maximum exceedance
		No.	Max (mm/s)	
Monitoring Location A	7222	2*	10.6	29-Feb, 3:57 pm
Monitoring Location B	7285	0	-	-

*Exceedances were isolated impulsive events, possibly caused by bumps to or near the sensor.
