# Construction Soil and Water Management Plan

UNSW Health Translation Hub

**Prepared for: Hansen Yuncken**

**Document no: B-ACO-CEC-RPT-0001**

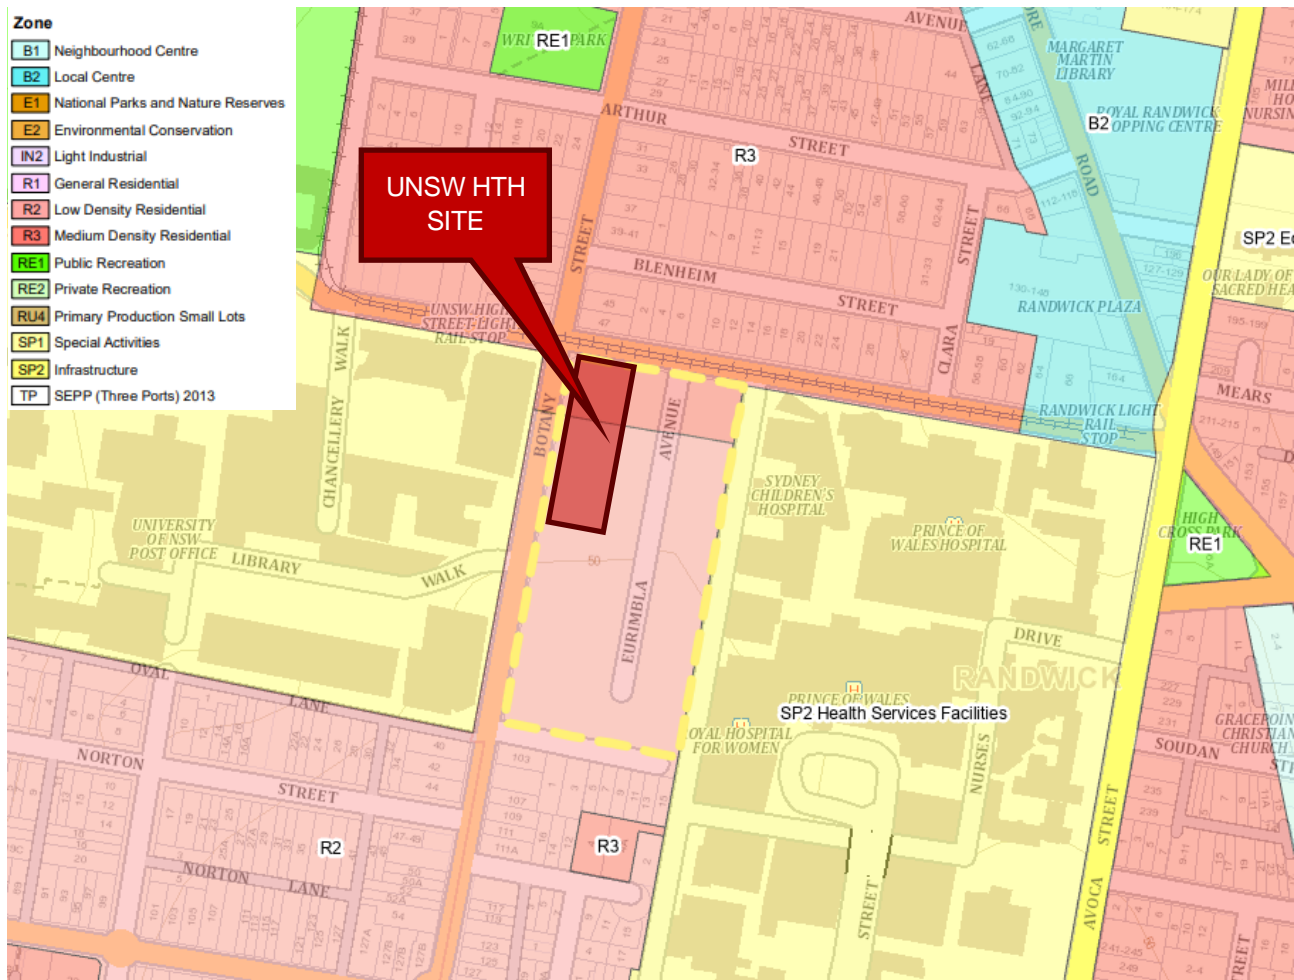
Figure 3 – Land Use Map (Source: NSW ePlanning Spatial Viewer)

The existing land use is R2 Low Density Residential and R3 Medium Density Residential with minimal vegetation, see Figure 3 below.

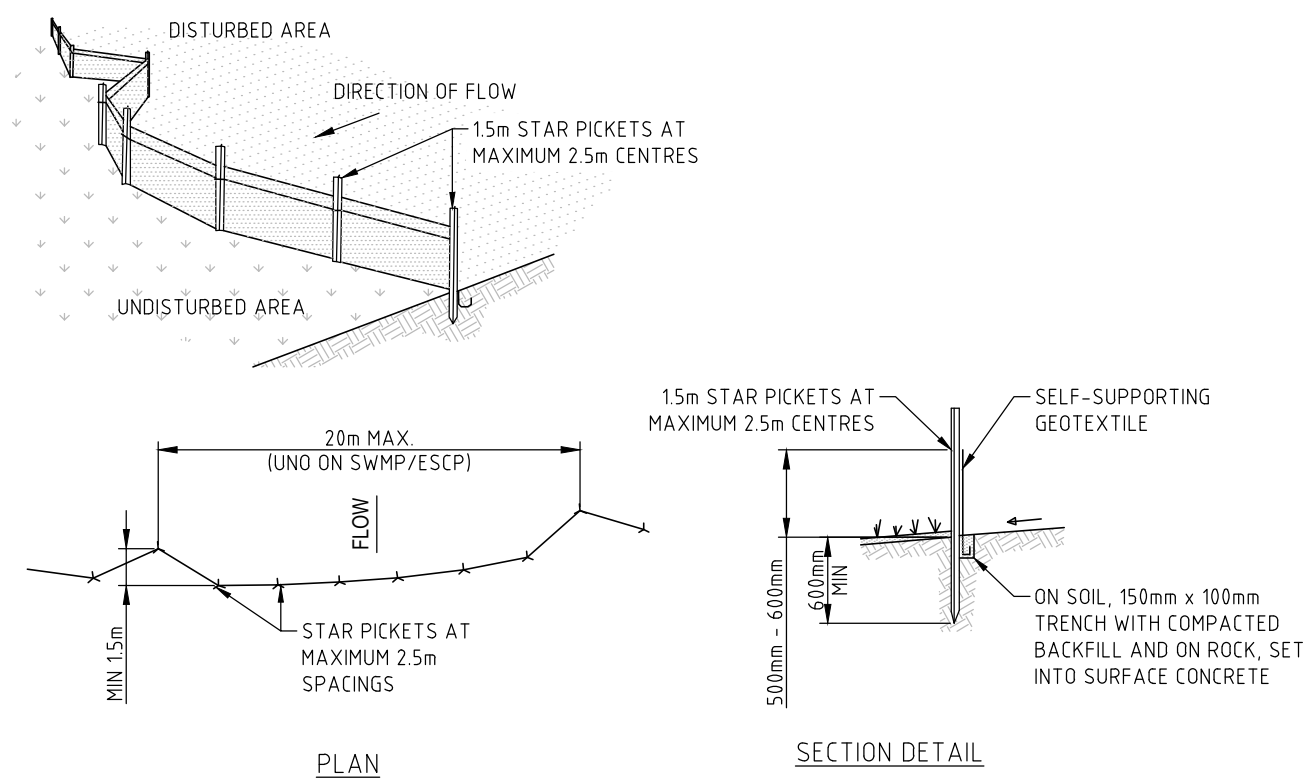
### SEDIMENT CONTROL FENCE

1. CONSTRUCT SEDIMENT FENCE AS CLOSE AS POSSIBLE TO PARALLEL TO THE CONTOURS OF THE SITE
2. DRIVE 15m LONG STAR PICKETS INTO GROUND, 2.5 METRES APART (MAX). ENSURE STAR PICKETS ARE FITTED WITH SAFETY CAPS.
3. DIG A 150mm DEEP TRENCH ALONG THE UPSLOPE LINE OF THE FENCE FOR THE BOTTOM OF THE FABRIC TO BE ENTRENCHED.
4. BACKFILL TRENCH OVER BASE OF FABRIC
5. FIX SELF-SUPPORTING GEOTEXTILE TO UPSLOPE SIDE OF POSTS WITH WIRE TIES OR AS RECOMMENDED BY GEOTEXTILE MANUFACTURER.
6. JOIN SECTIONS OF FABRIC AT A SUPPORT POST WITH A 150mm OVERLAP.
