Memorandum

To	Hansen Yuncken Pty Ltd	Marcus Amico	mamico@hansenyuncken.com.au
From	Jeremy Hill	Date	05 Oct 2023
Subject	UNSW Health Translation Hub Corner of Botany and High Streets, Randwick	Project No.	99852.02
		Document No.	VR.004.Rev0

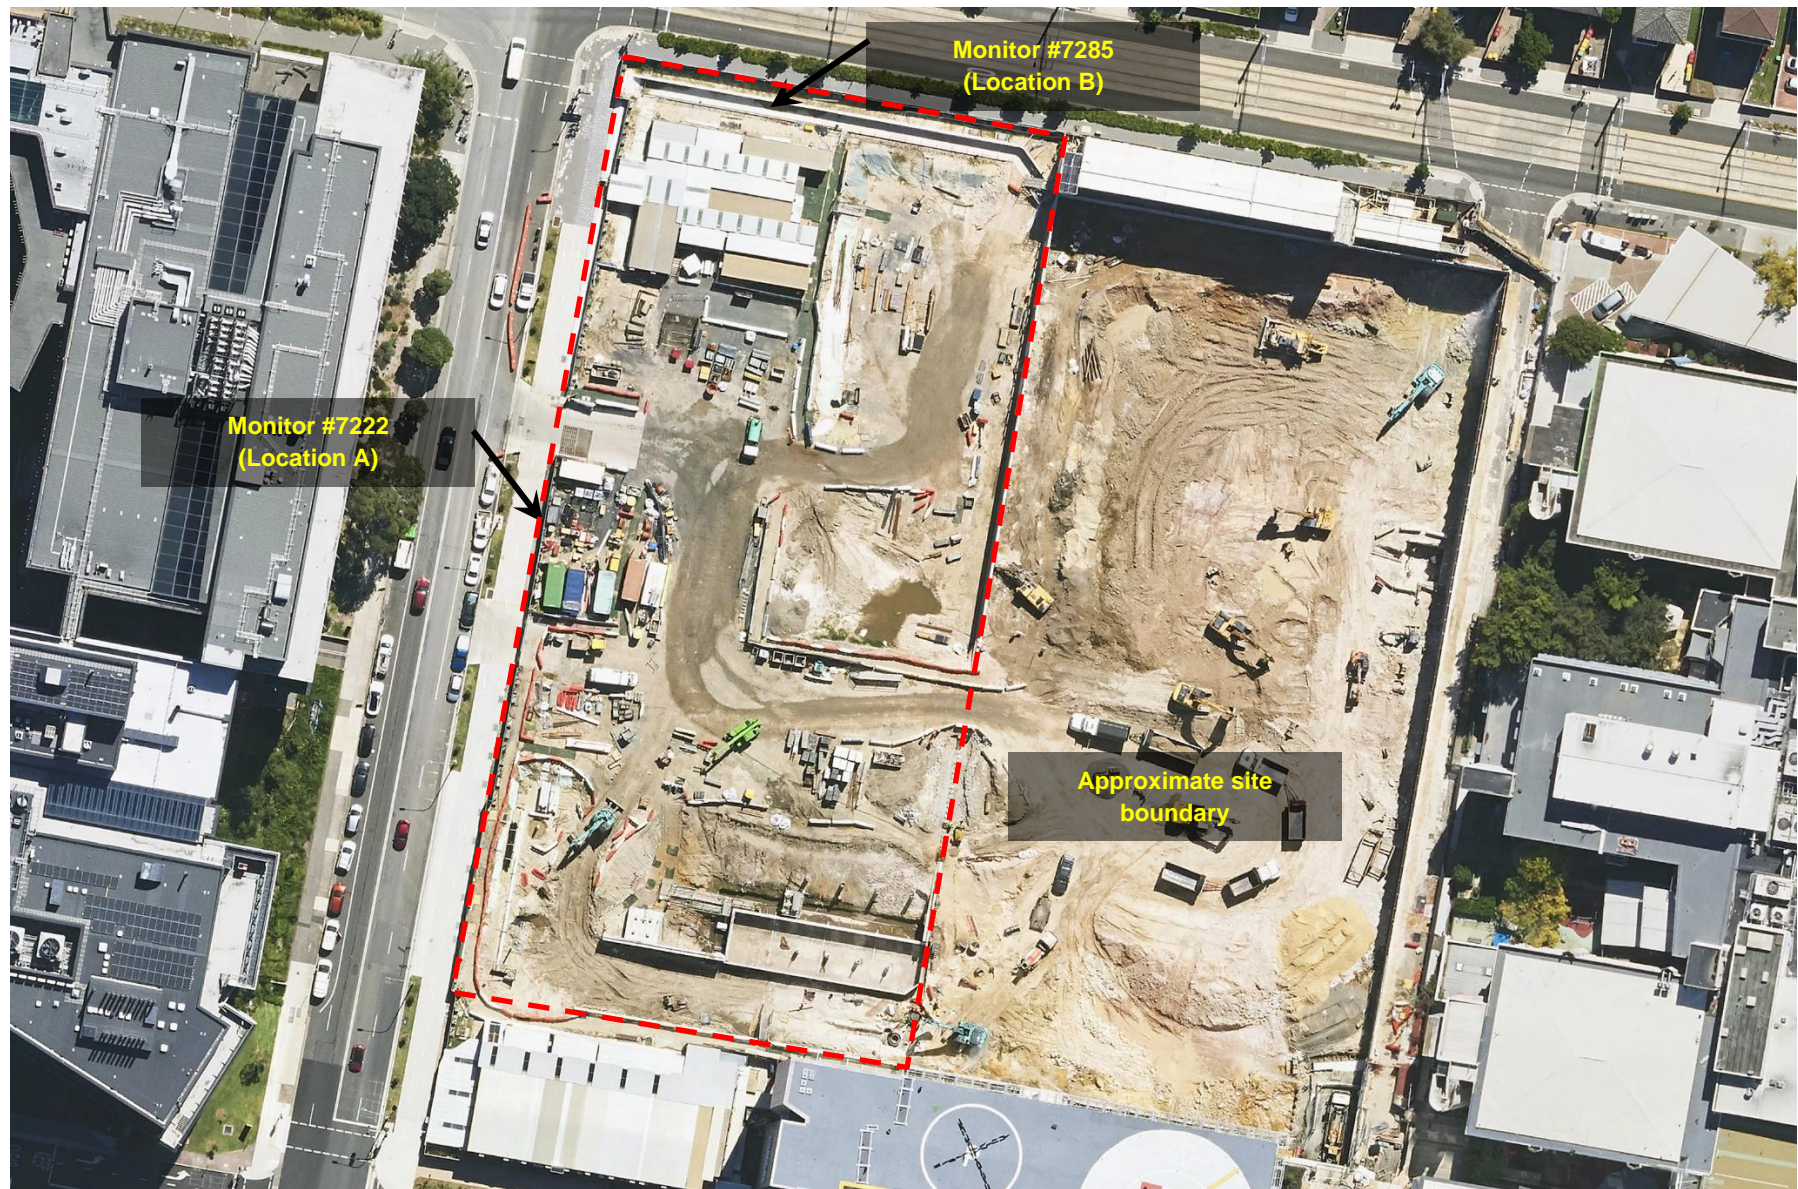
Monitor **7285**

Notes: *Analysis of waveform indicates exceedances were likely caused by a direct impact to sensor or near to the sensor.
