Memorandum

To	Hansen Yuncken Pty Ltd	Marcus Amico	mamico@hansenyuncken.com.au
From	Jeremy Hill	Date	23 Oct 2023
Subject	UNSW Health Translation Hub Corner of Botany and High Streets, Randwick	Project No.	99852.02
		Document No.	VR.005.Rev0

Table 1: Results of Vibration Monitoring, 25 September – 21 October 2023

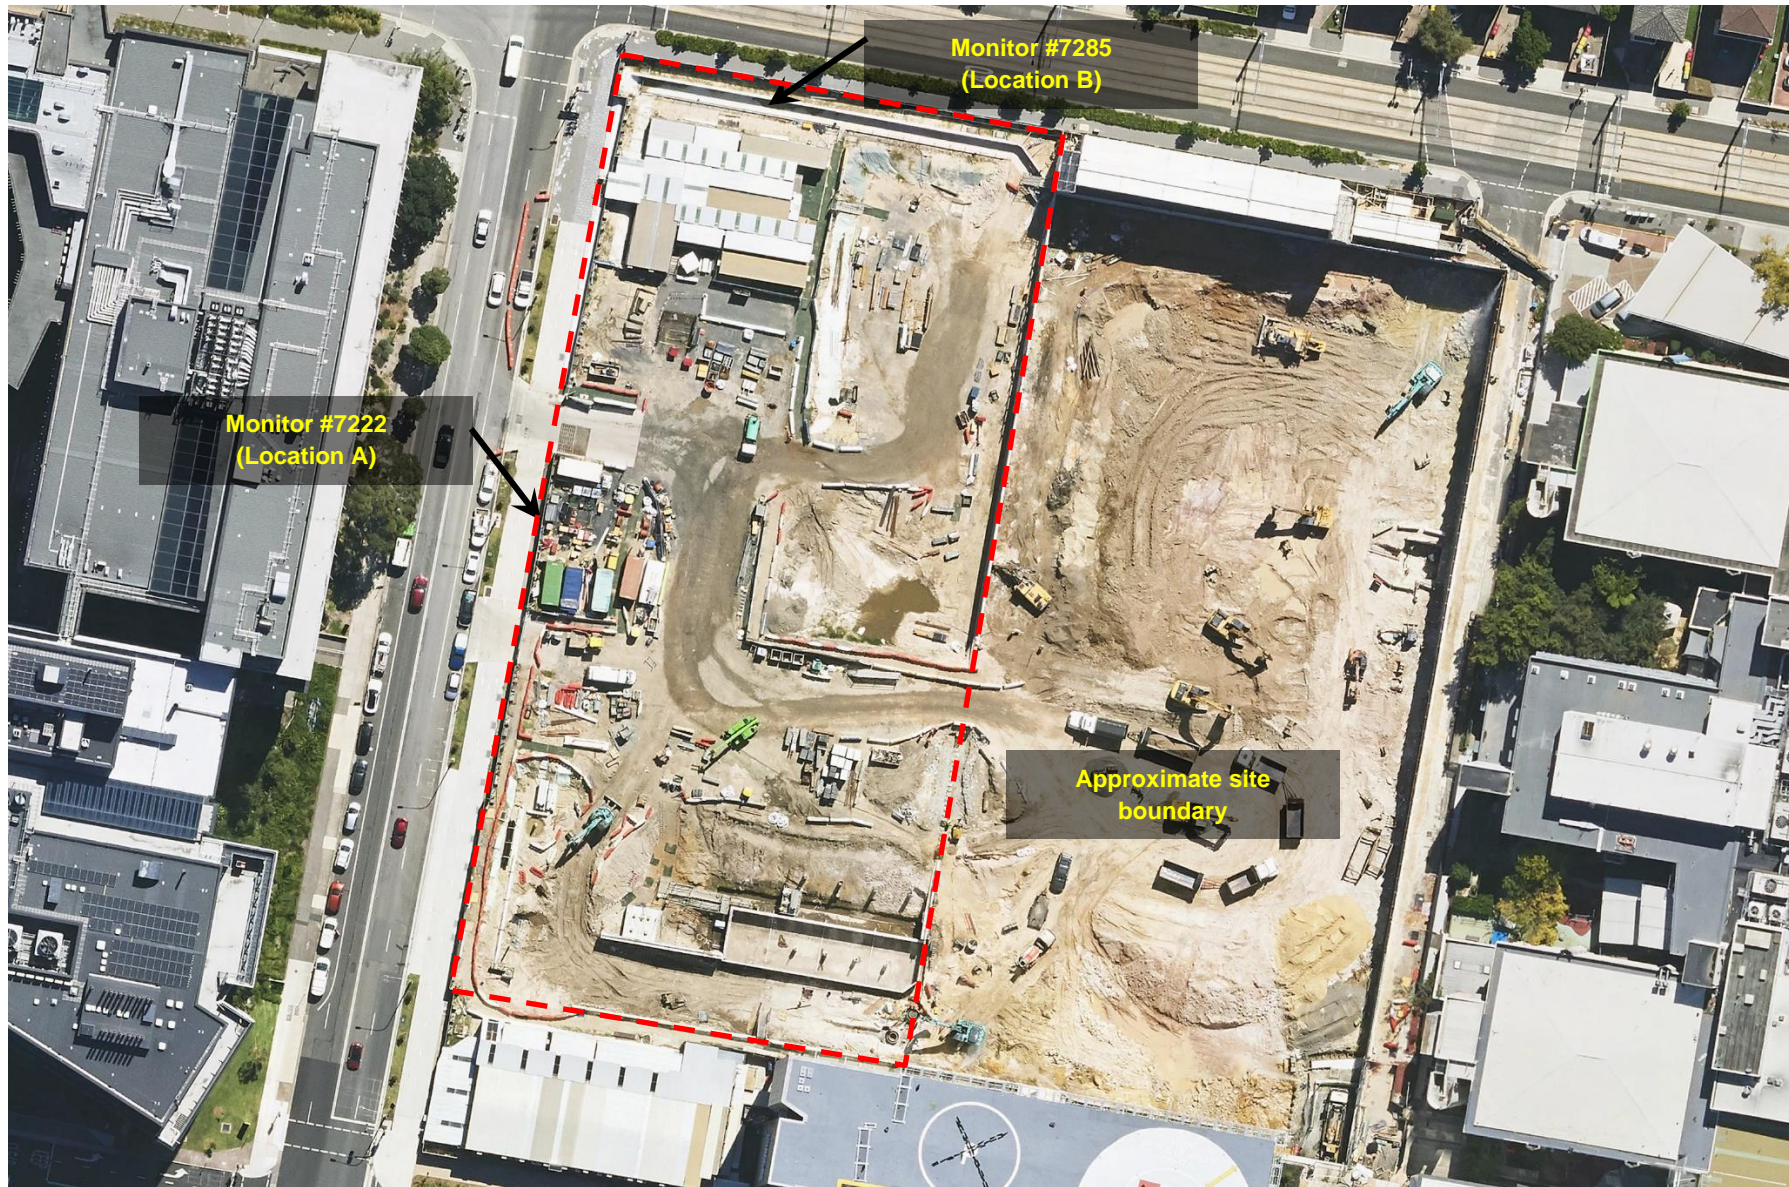
Ambient levels are recorded at 5min intervals and drawn evenly spaced. For display purposes, the axis is stretched where triggered events occur.

Date and Time
Duty Cycle 6am - 6pm Mon - Sat (not continuous overnight)
