## Memorandum

<b>To</b>	Hansen Yuncken Pty Ltd	Marcus Amico	mamico@hansenyuncken.com.au
<b>From</b>	Jeremy Hill	<b>Date</b>	29 Aug 2023
<b>Subject</b>	UNSW Health Translation Hub Corner of Botany and High Streets, Randwick	<b>Project No.</b>	99852.02
		<b>Document No.</b>	VR.003.Rev0

**Table 1: Results of Vibration Monitoring, 31 July – 26 August 2023**

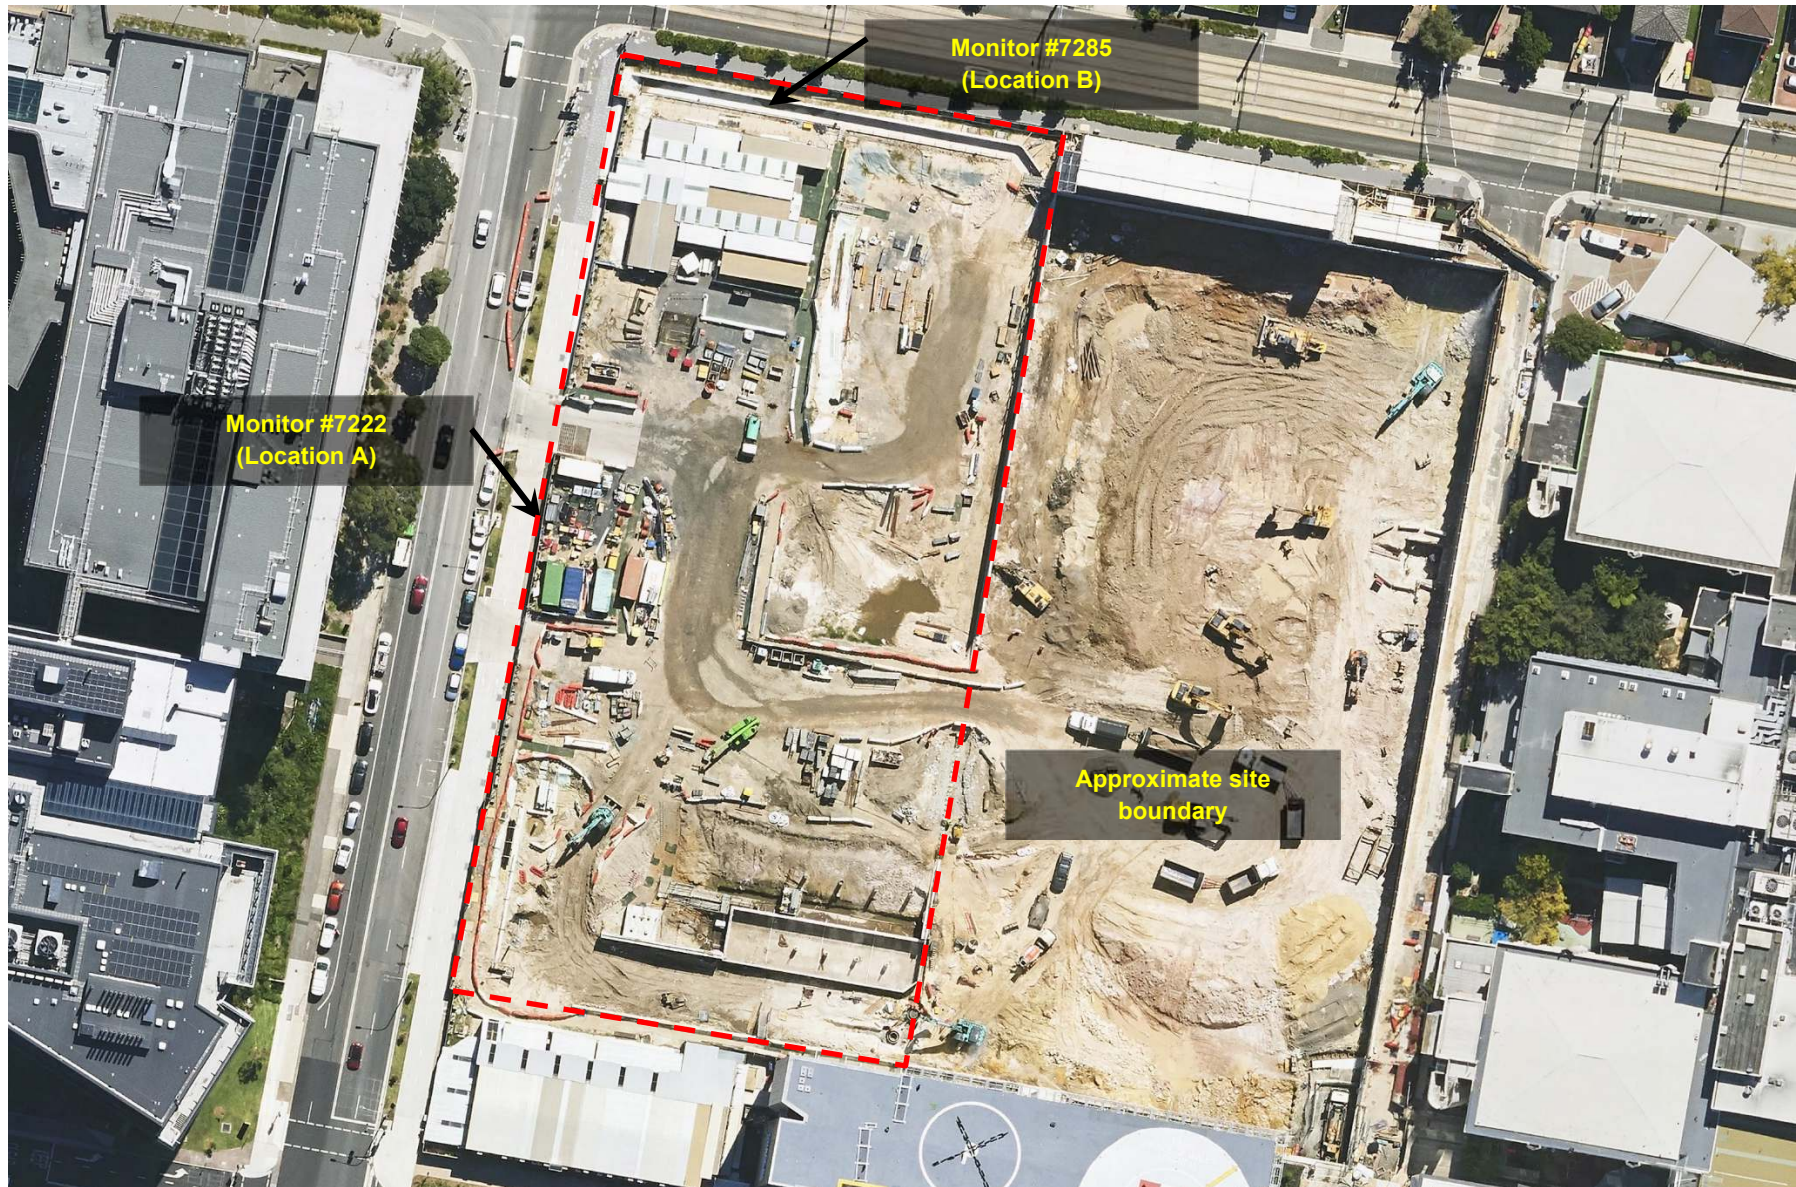
Monitor **7285**

Location	Monitor	Exceedances (VSPPV)		Time of maximum exceedance
		No.	Max (mm/s)	
Monitoring Location A	7222	1*	13.8	9-Aug, 9:47 am
Monitoring Location B	7285	53**	>55	17-Aug 8:45 am

\*\* Analysis of waveforms for the period indicates that most exceedances were impulsive events, likely caused by direct bumps to or movement of sensor. The site manager reported that staff were bumping the sensor during plumbing works on 17 and 18 August. A DP site visit on 24 August found that the sensor was dislodged from its original mounting position on the ground surface. The sensor was subsequently reinstalled correctly. The vibration levels recorded for the period 17-24 August by Monitor 7285 may be inaccurate due to improper coupling of the sensor with the ground.
