Construction Soil and Water Management Plan

UNSW Health Translation Hub

Prepared for: Hansen Yuncken

Document no: B-ACO-CEC-RPT-0001

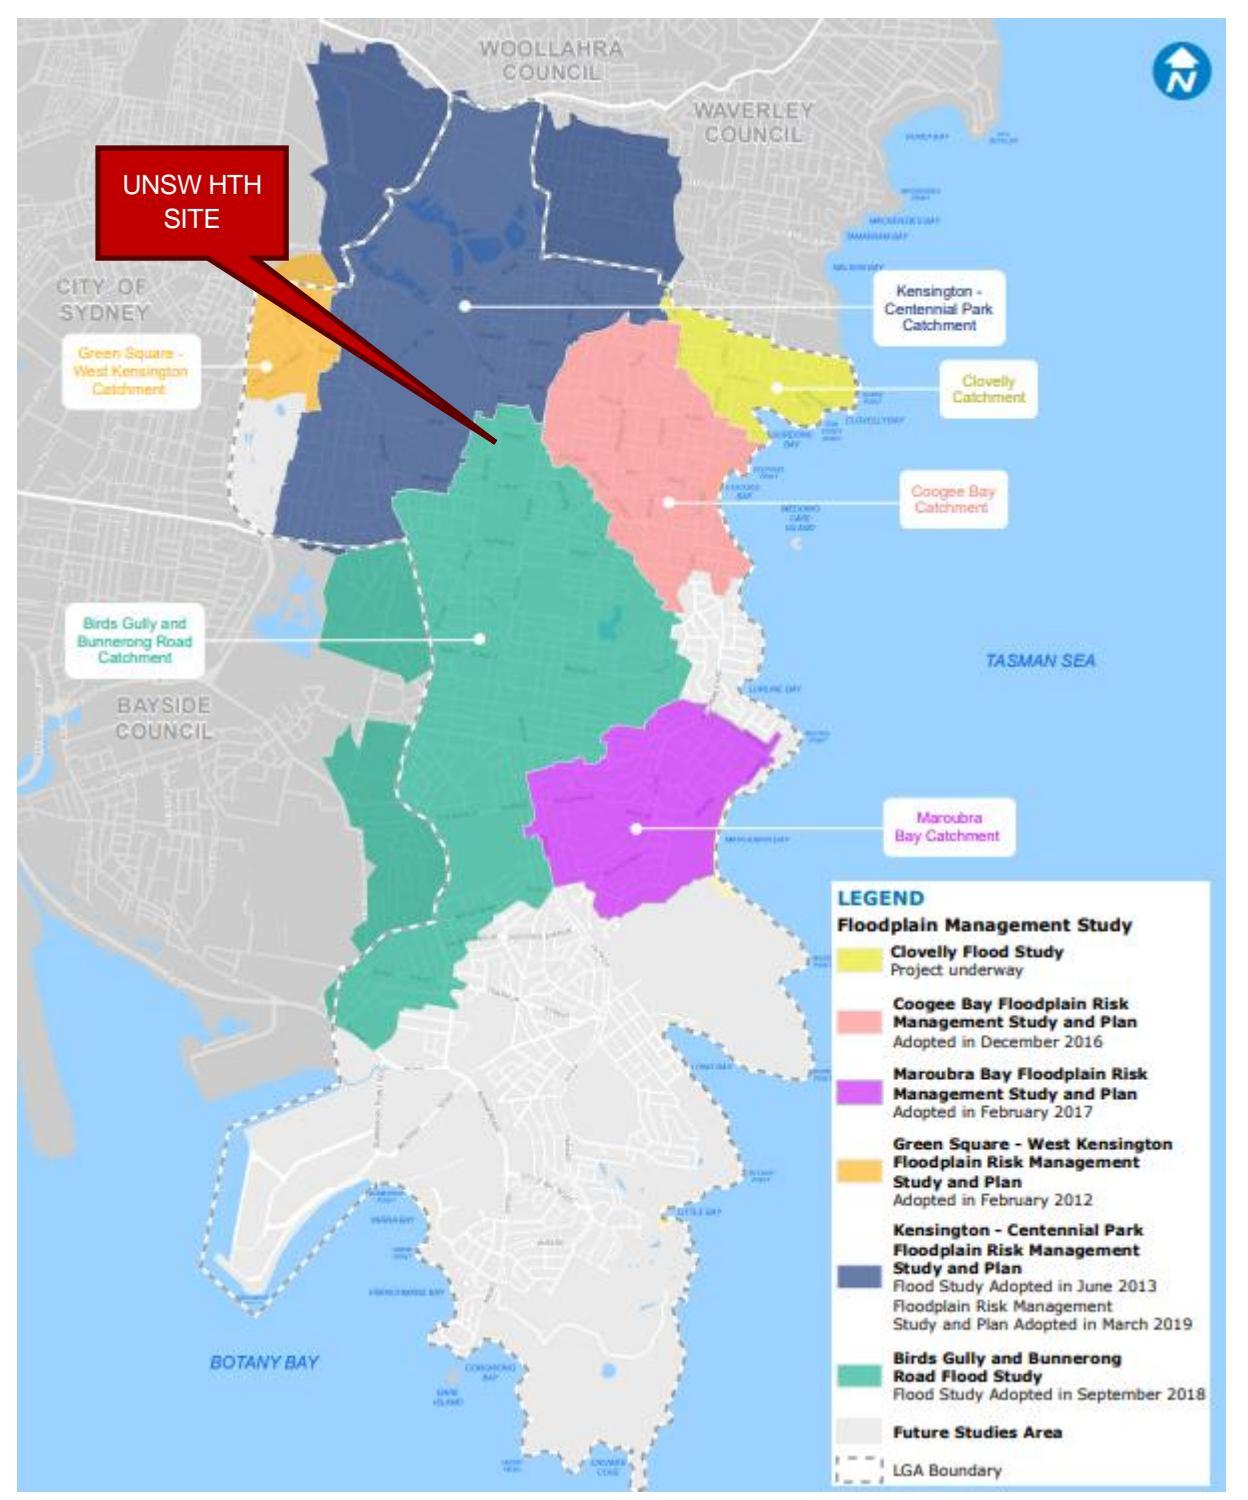
Figure 2 – Randwick City Council Flood Study Areas (Source: RCC, 2019)

The Site generally falls from North-West to South-East and lies within the Birds Gully and Bunnerong Road Catchment area.

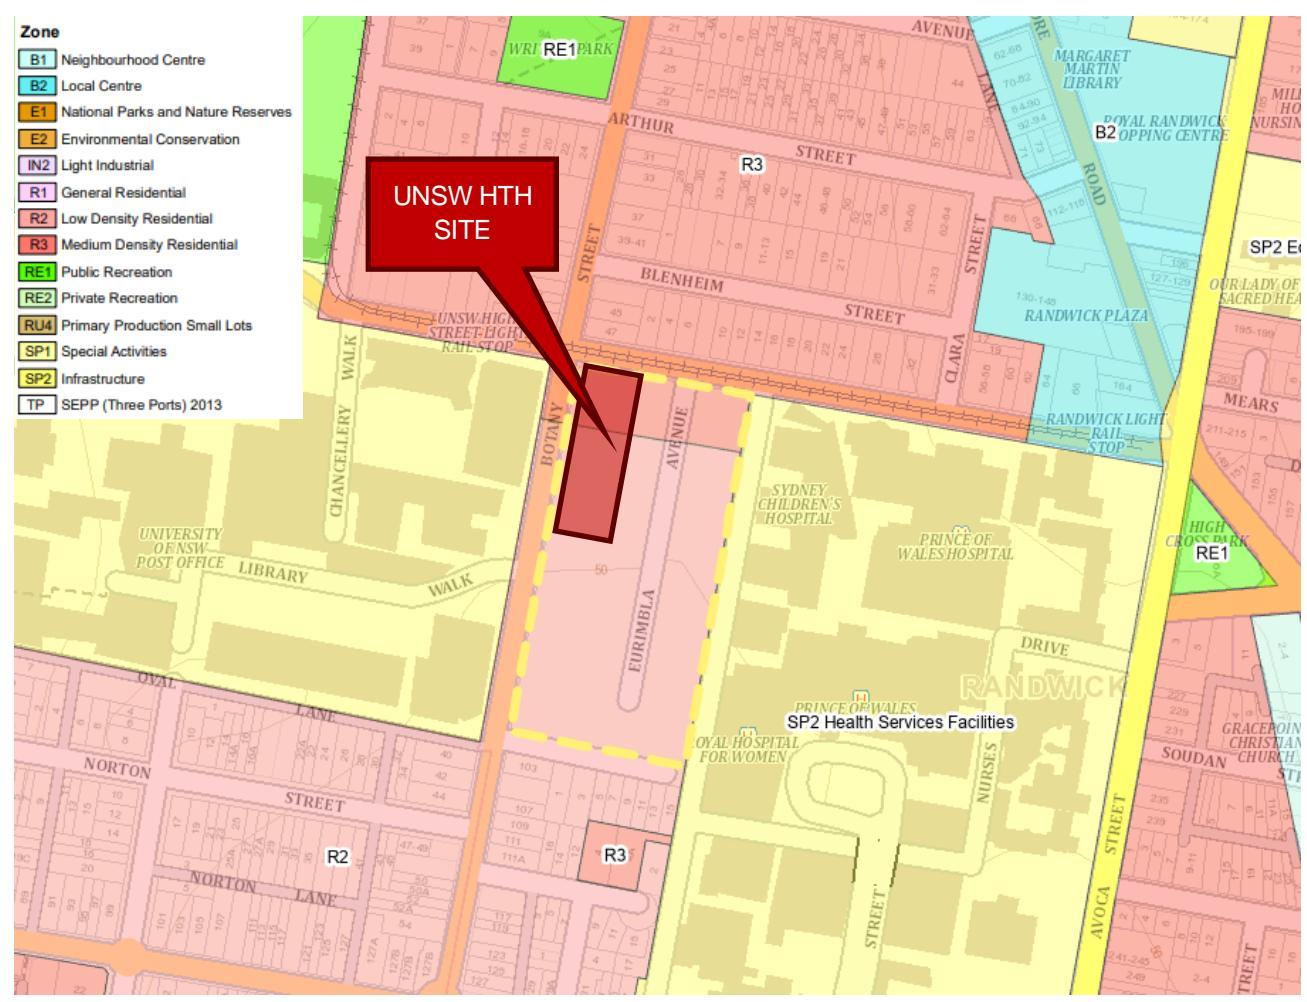
Figure 3 - Land Use Map (Source: NSW ePlanning Spatial Viewer)

The existing land use is R2 Low Density Residential and R3 Medium Density Residential with minimal vegetation, see Figure 3 below.

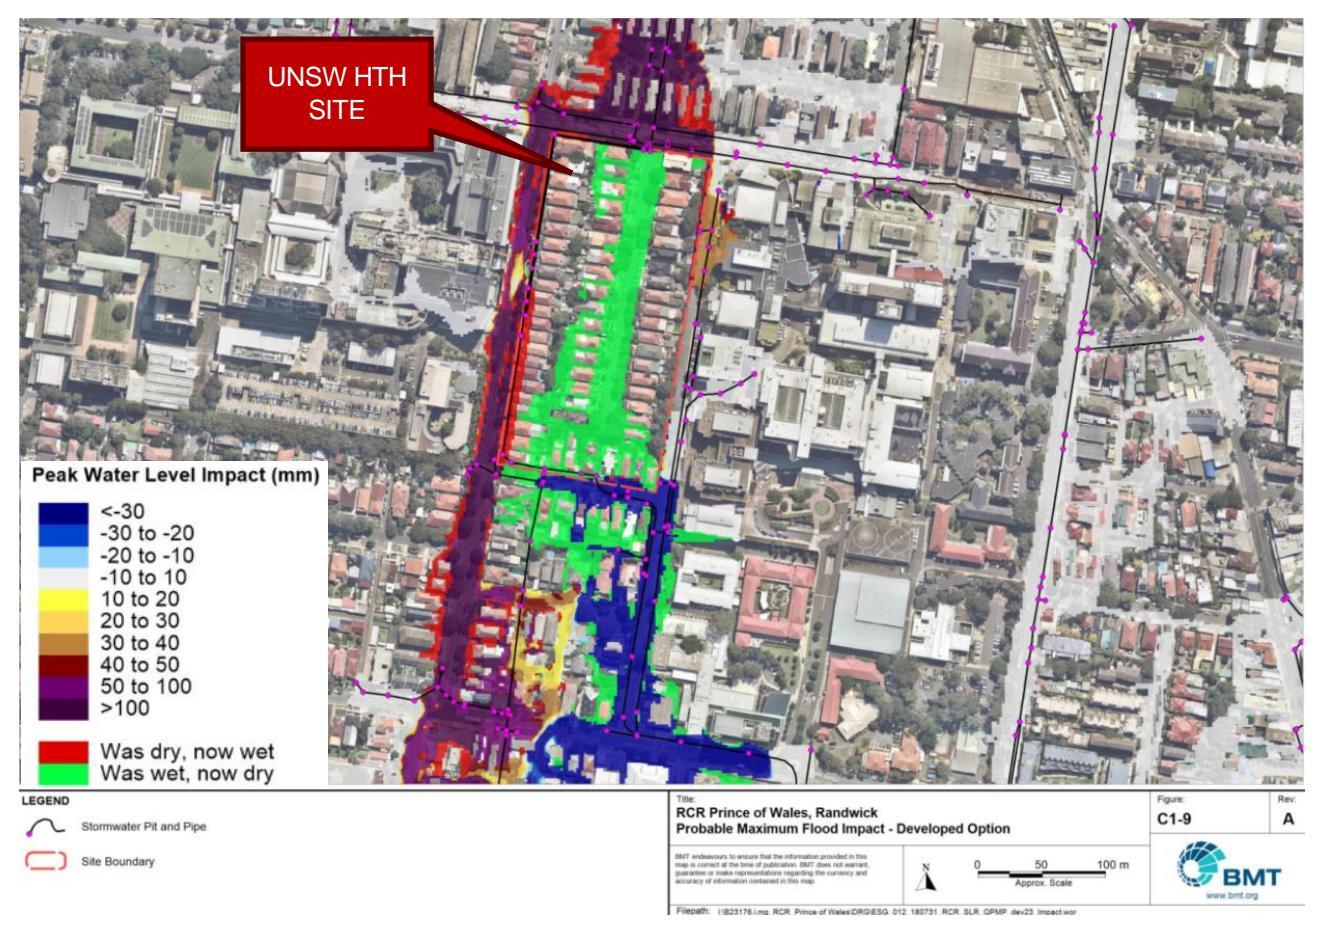
Figure 4 – Peak Water Level Impacts during PMF Event – Developed Option (Source: BMT, 2018)

¹ Provided by adjacent Sydney Children's hospital (SCH) Stage 1 and Comprehensive Children's Cancer Centre (CCCC) project team – based on flood model developed for Integrated Acute Services Building (IASB) ² RL55.738 + 500mm freeboard = RL56.238

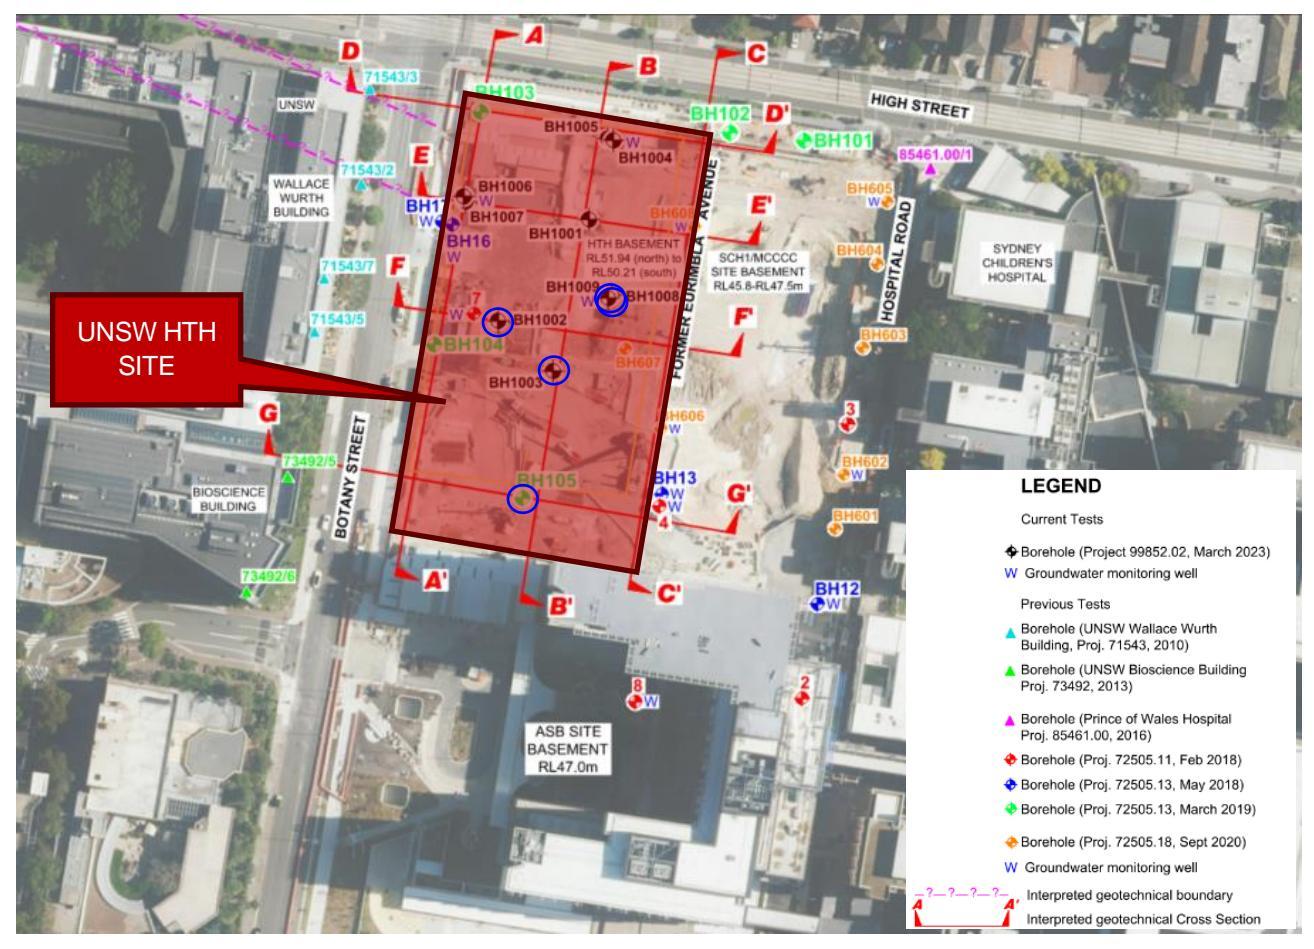
Figure 5 – Locations of boreholes (Source: Douglas Partners, 2023)

The Southern (lower) basement for HTH is proposed at RL50.21 (BEL⁴47.71) and the Northern (upper) basement at RL51.94 (BEL51.59), which lie above the highest detected level of groundwater (RL49.50 at BH1002). As such, it is not anticipated there will be contamination to groundwater due to groundwater interception.

Item (vi) of Condition B15 has been addressed in Section 4 with reference to the Geotechnical Report borehole logs prepared by Douglas Partners dated February 2021. Water detected in the Southern borehole log (BH105) to be below the lower basement level of RL50.21 (Bulk Earthworks Level BEL47.71) on the HTH site and therefore it is not anticipated that excavation works will result in groundwater contamination.

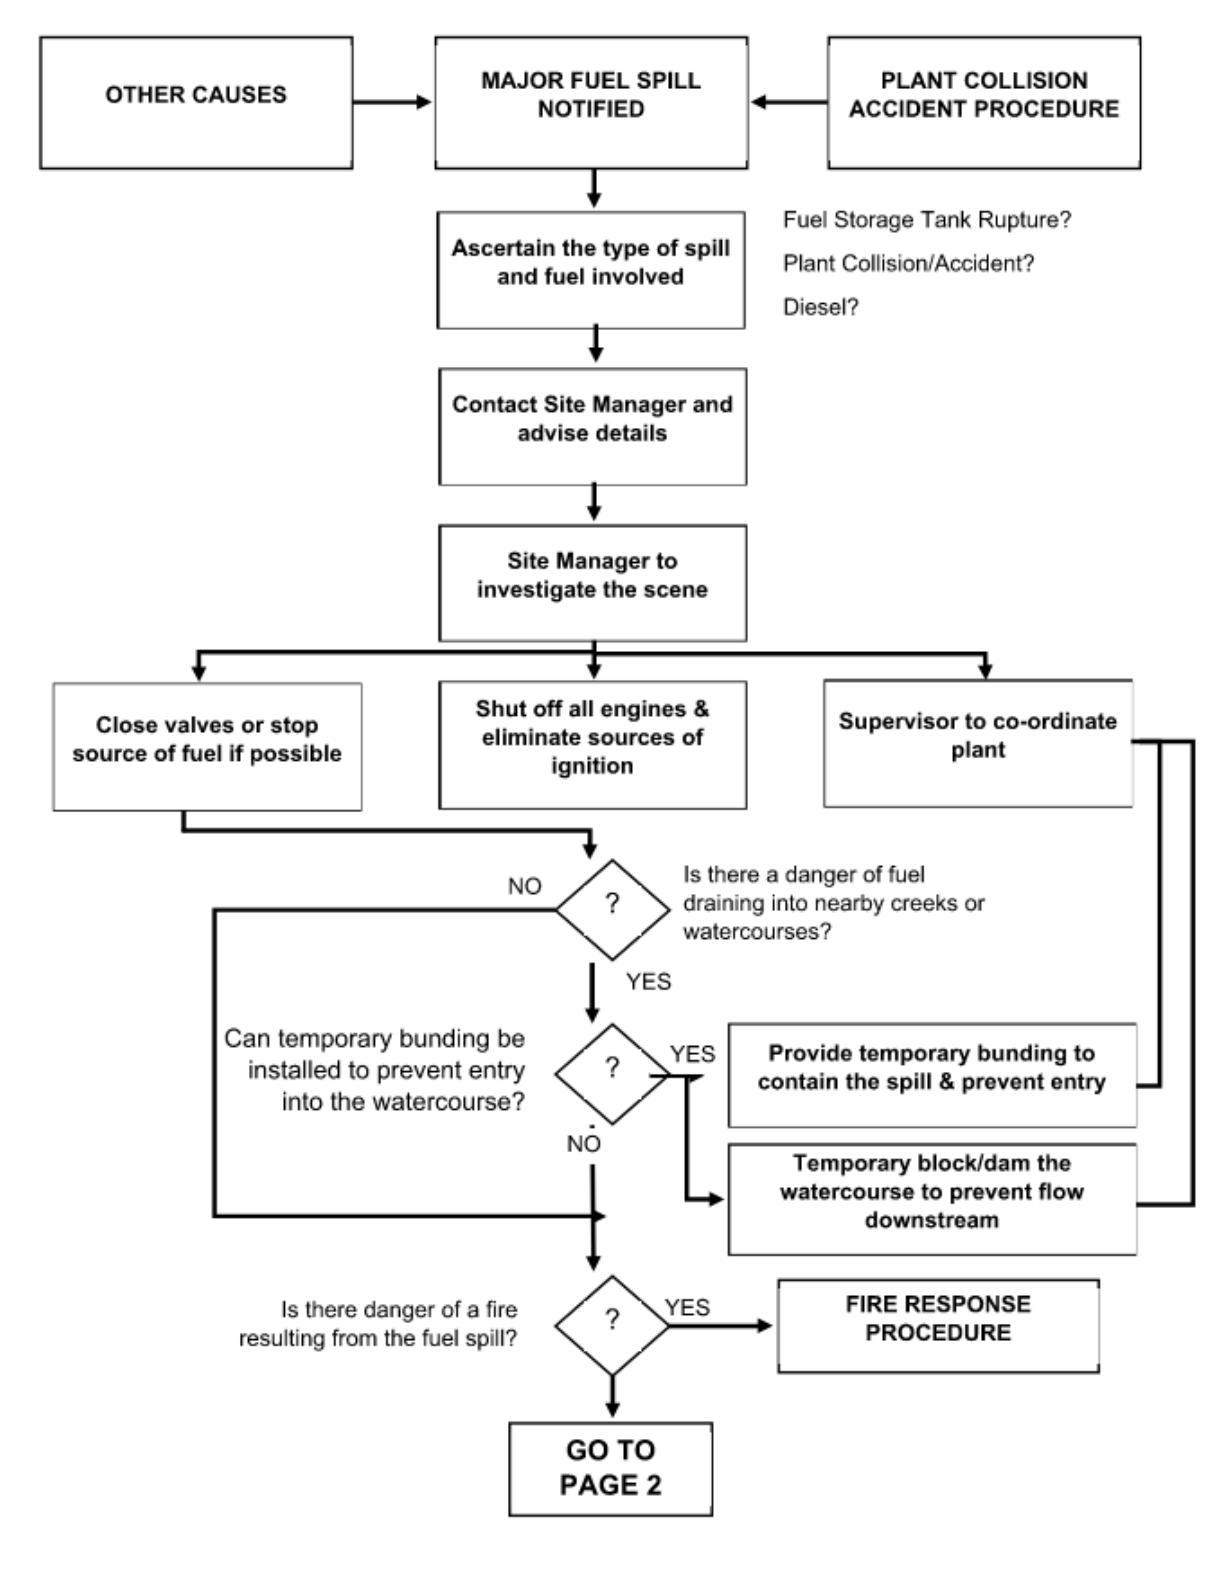
Figure 6 - Major Fuel Spill Response Part 1 Flow Chart (Source: Hansen Yuncken, 2022)

4.1.1.1 Major Fuel Spill

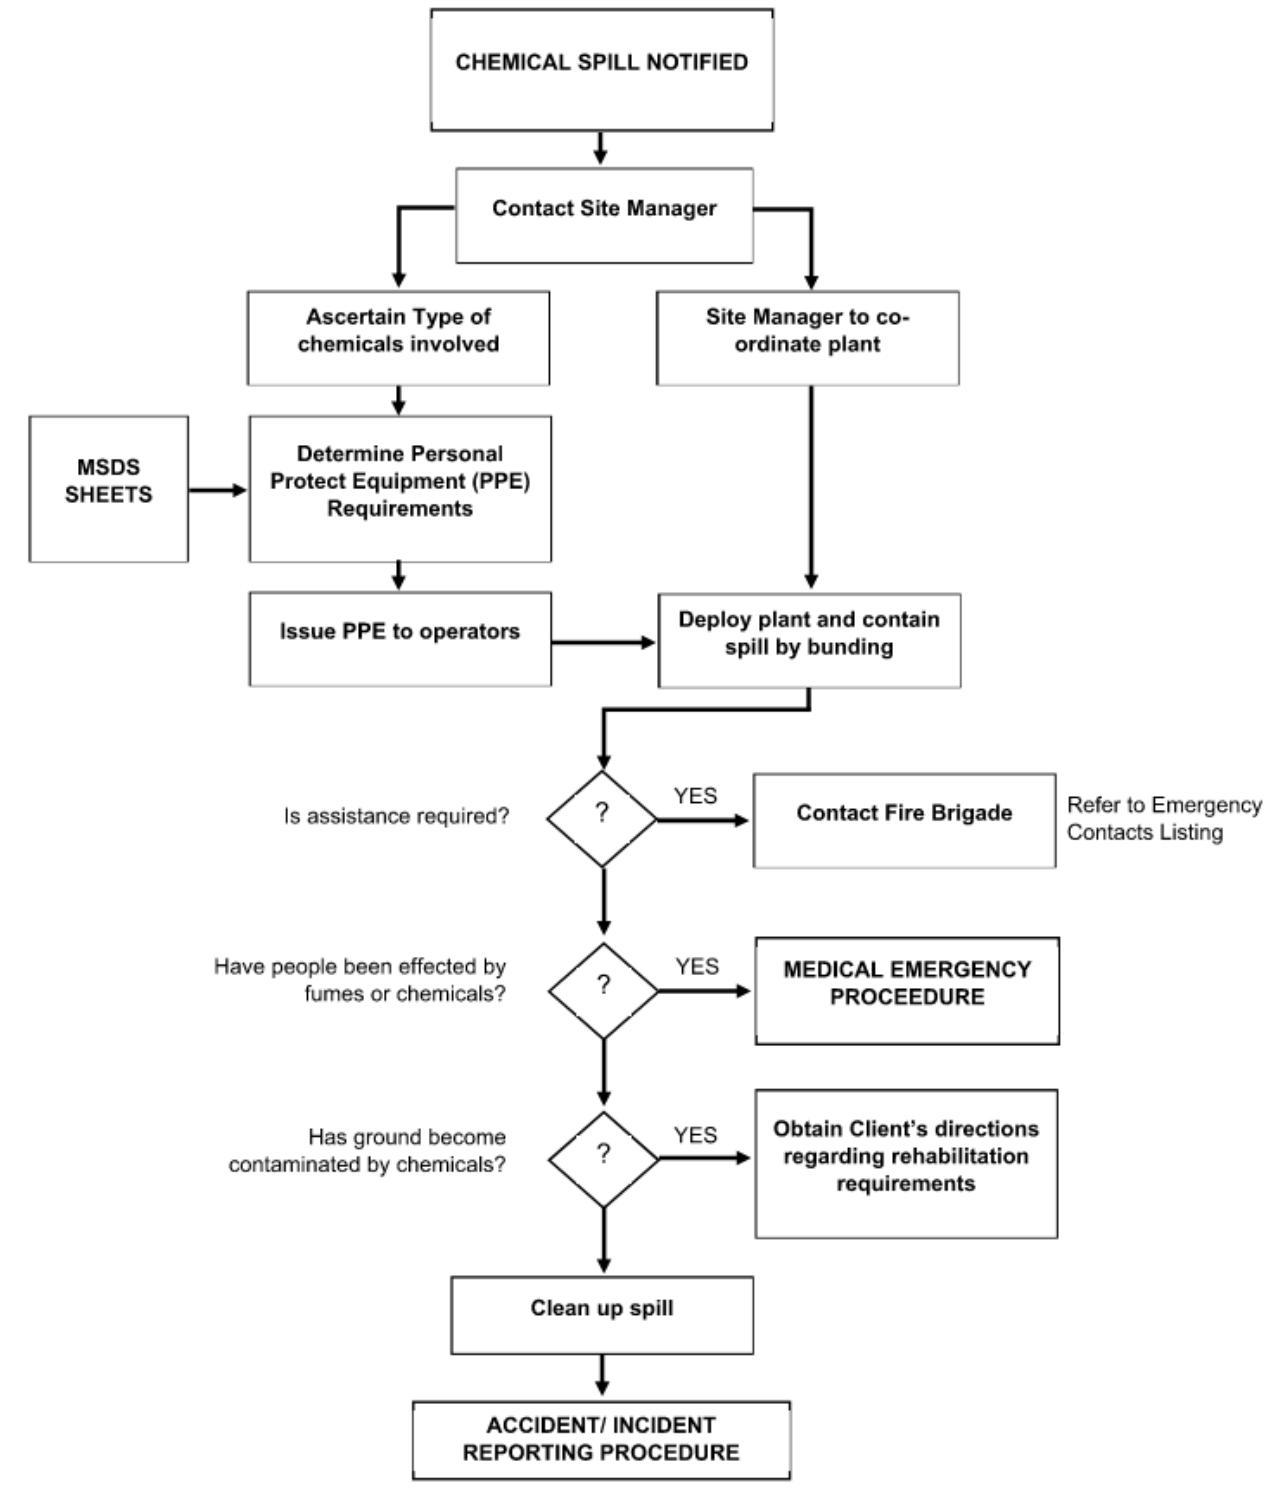
Figure 8 – Chemical Spills Response Flow Chart (Source: Hansen Yuncken, 2022)

4.1.1.2 Chemical Spills

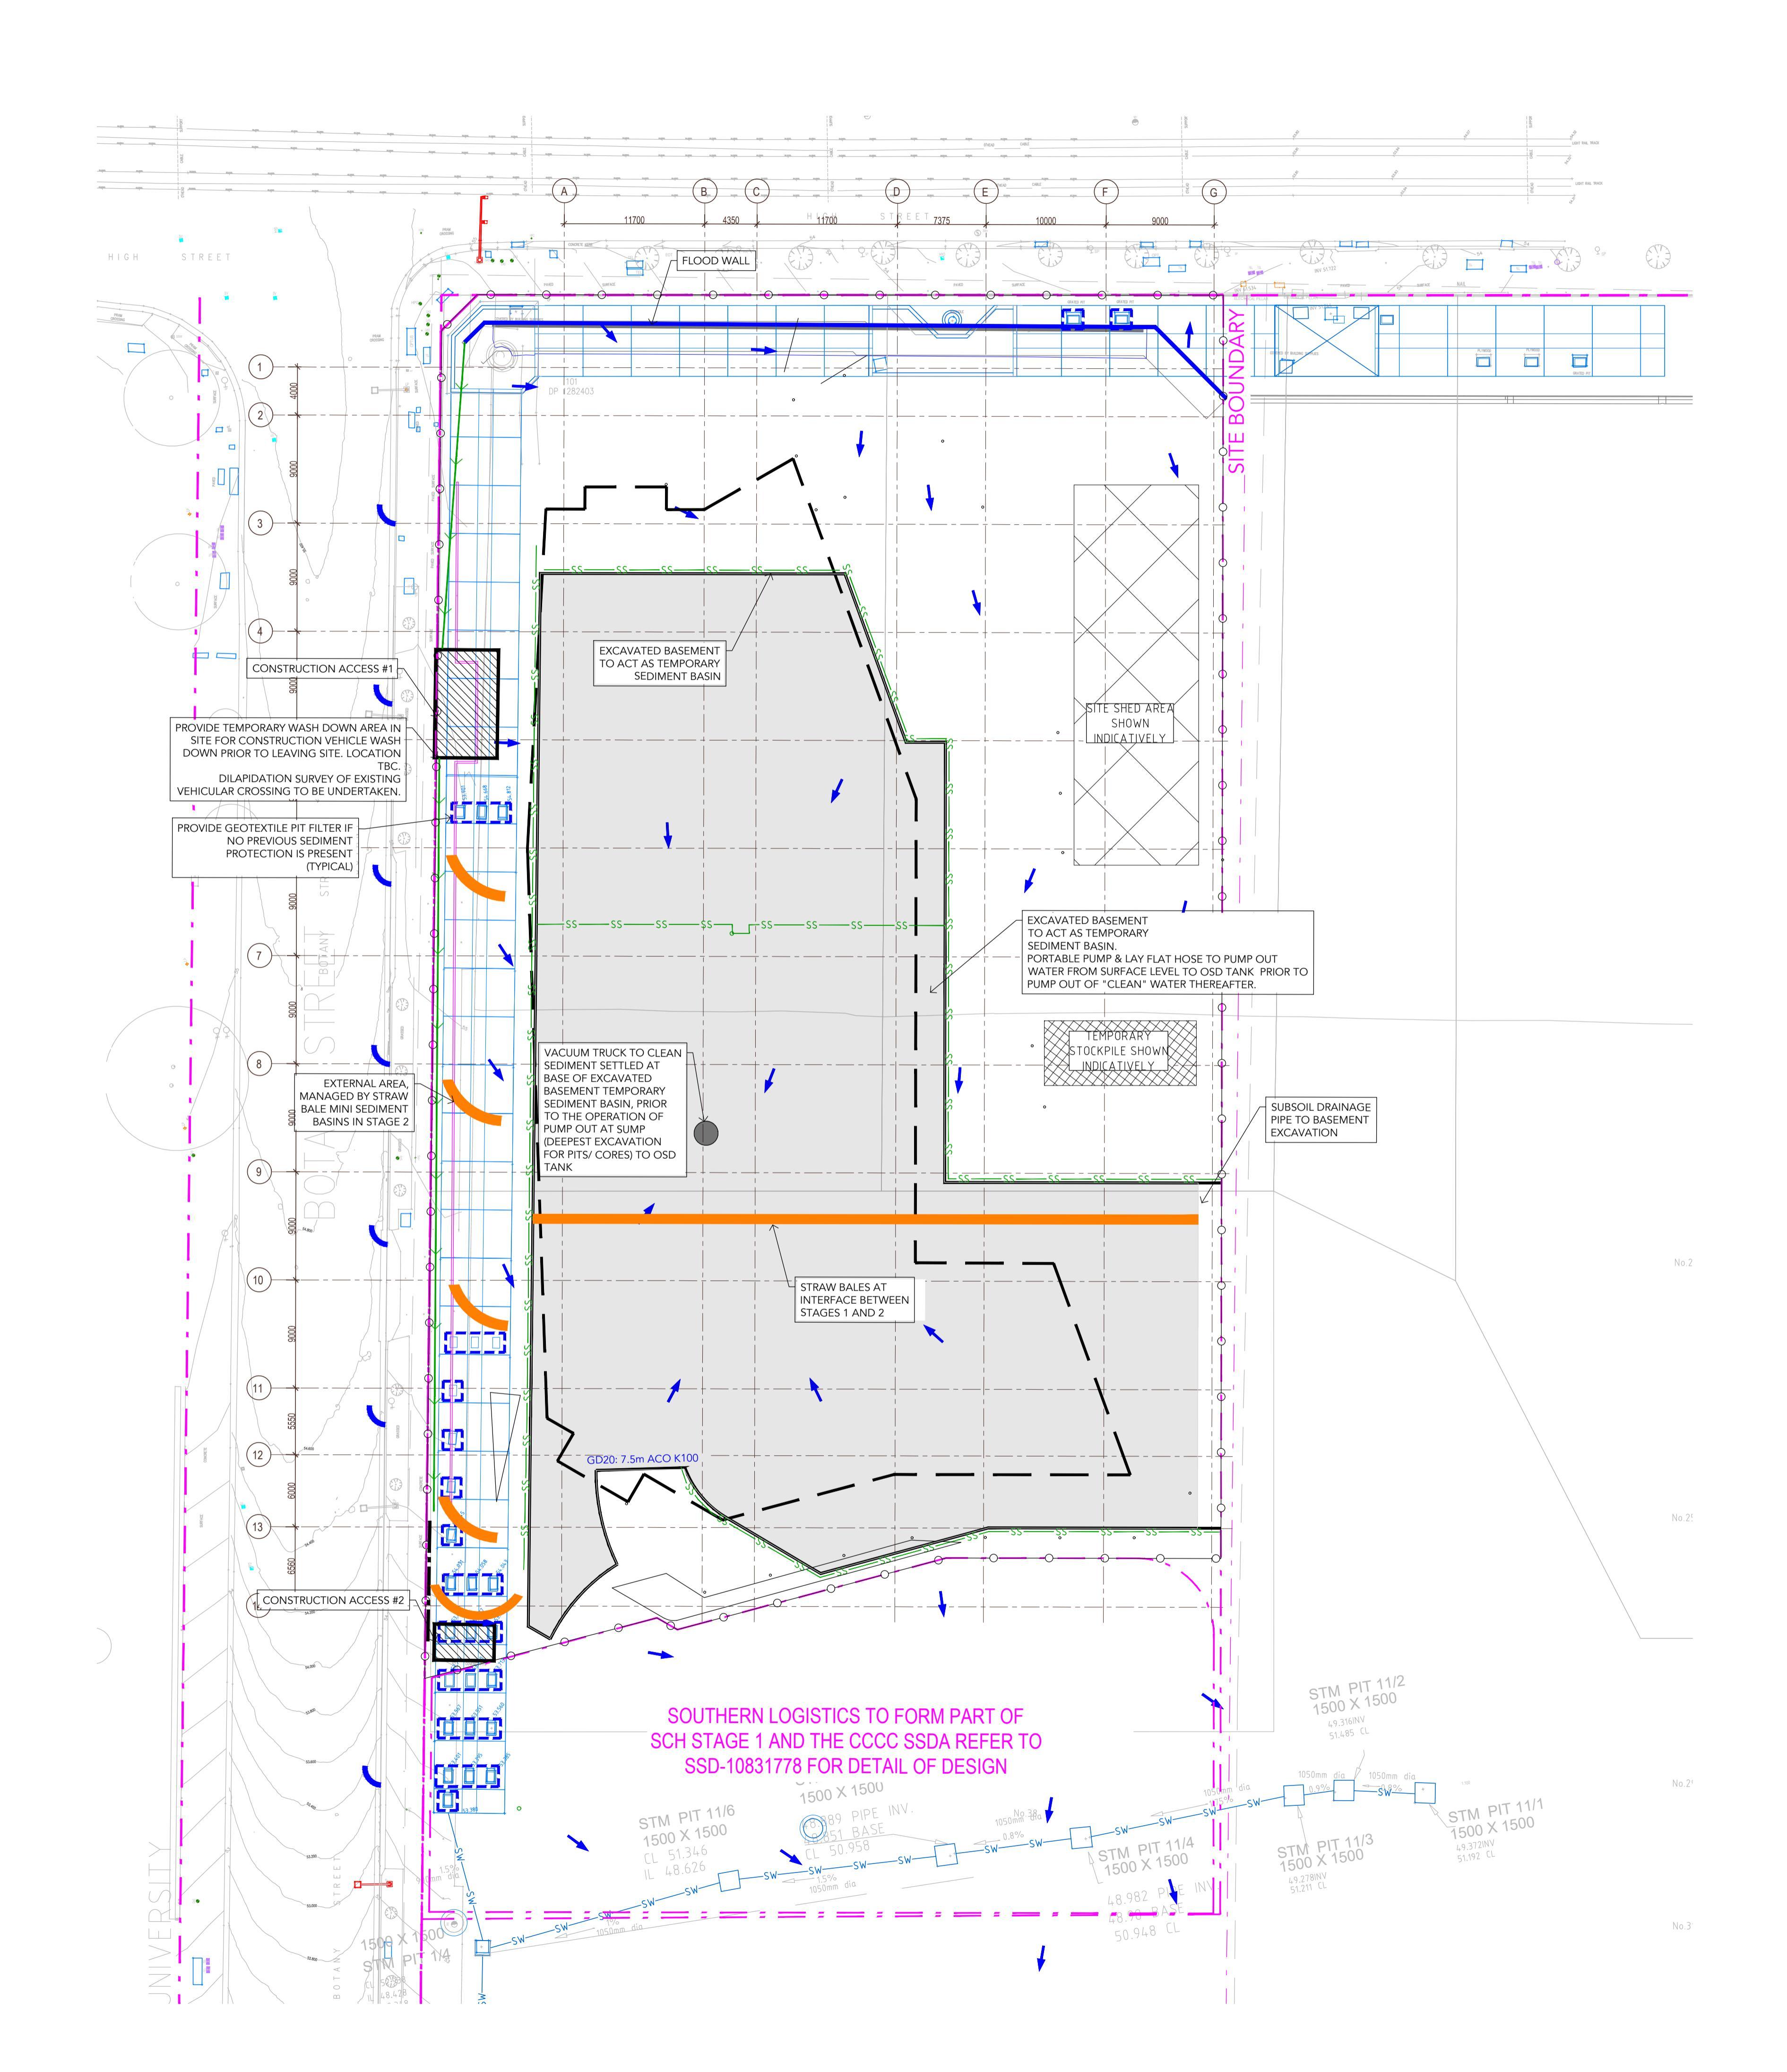
Drawing SOIL A PLAN	AND WATEF	RMANAGEMENT
Scale	1:250@B1	drawing no.
Drawn	J. Eaton	B-ACO-CEC-0600
Checked	S. Cai	issue
Project no	NSW212828	С

<u>STAGING:</u> STAGE 1 - EXCAVATION AND SITE SHEDS TO EXTERNAL EXTERNAL AREAS

Item (v) of Condition B15 has also been addressed in the SWMP (refer drawing no B-ACO-CEC-0600) via the provision of stabilised vehicular entry/ exit locations with vehicle shakedown systems (i.e., vehicle shake down devices at localised construction vehicle access/ egress points).
